HOME INSPECTION REPORT

123 21st Ave.
Somewhere, IL

Inspection Date: 1-1-00

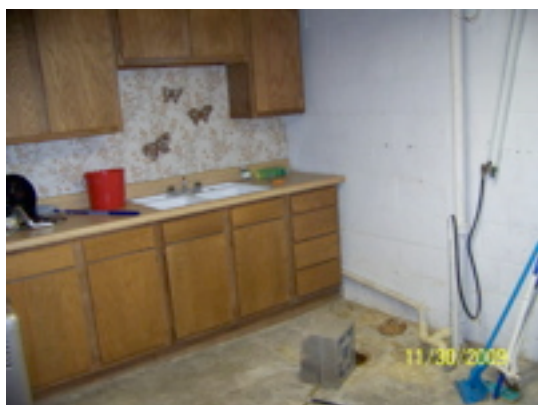
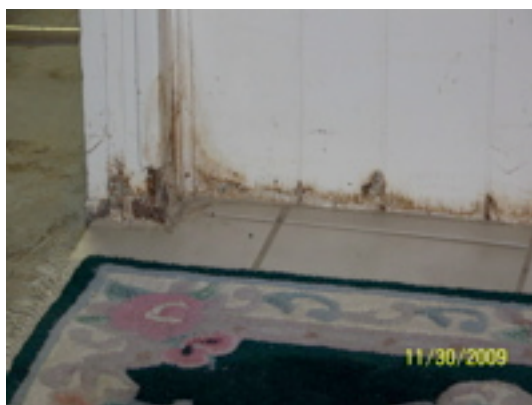
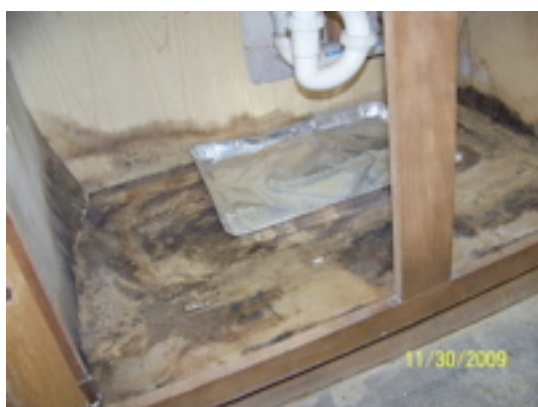
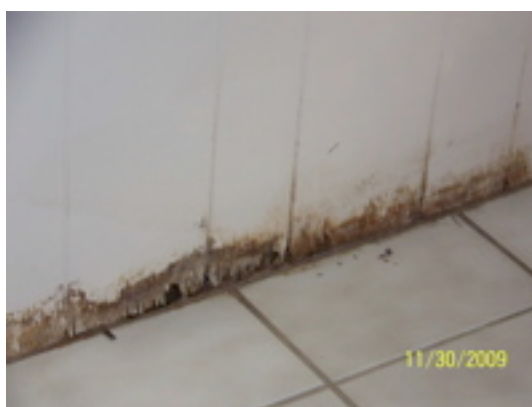
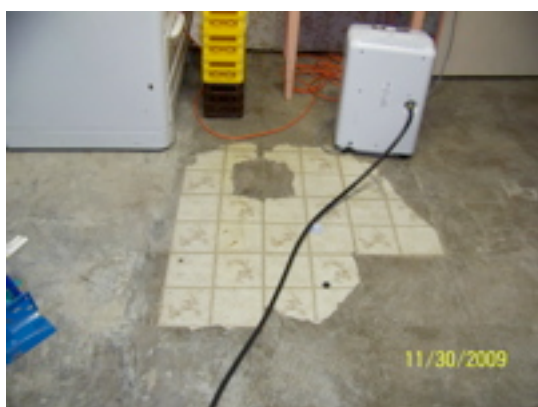
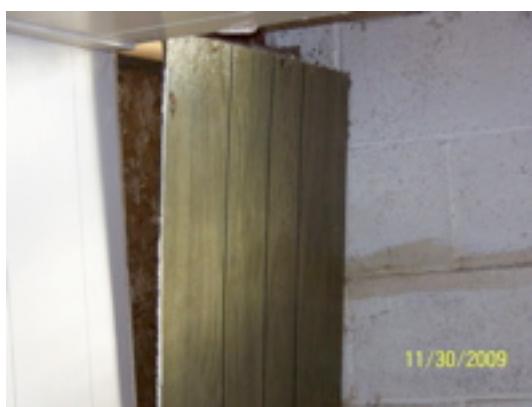
Basement comments & defective conditions

Defect: water damaged and rotted kitchen cabinets

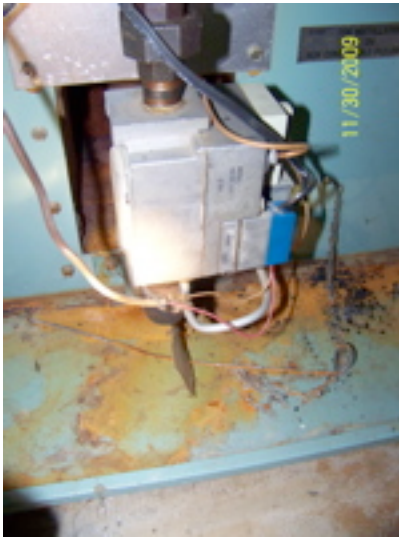
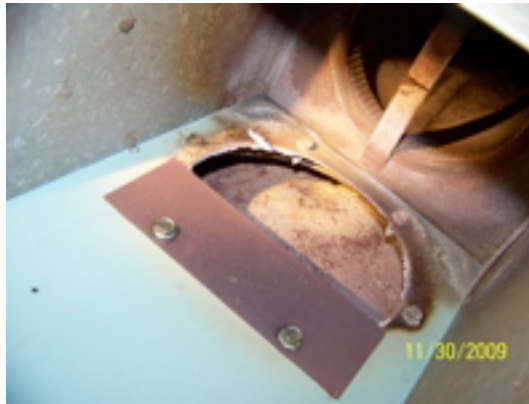
Heating comments & defective conditions

Defect: This furnace has reached the end of its' useful life cycle. Heat exchanger is rusted with flakes falling off.

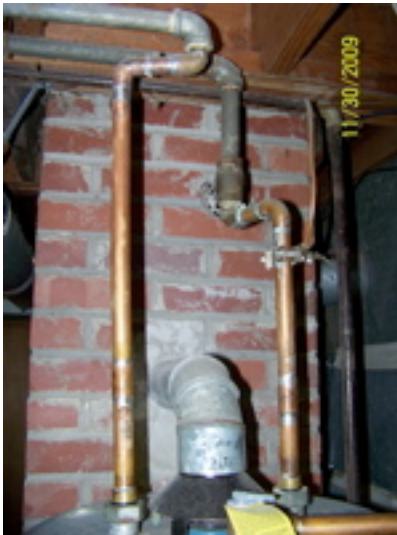
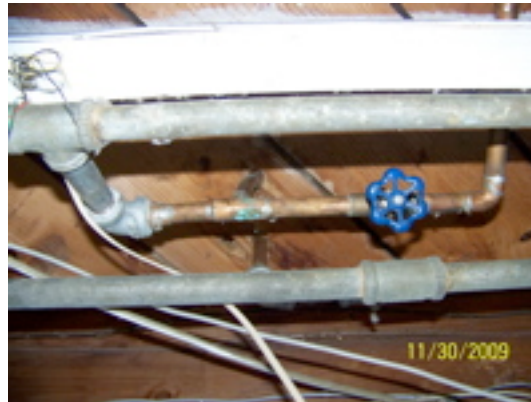
Plumbing comments & **defective** conditions:

Defect: numerous copper to galvanized pipe connections without dielectric unions

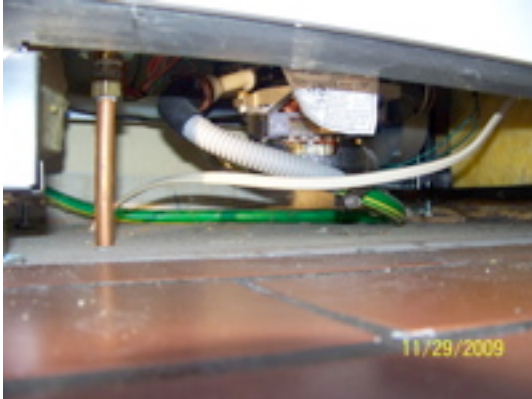
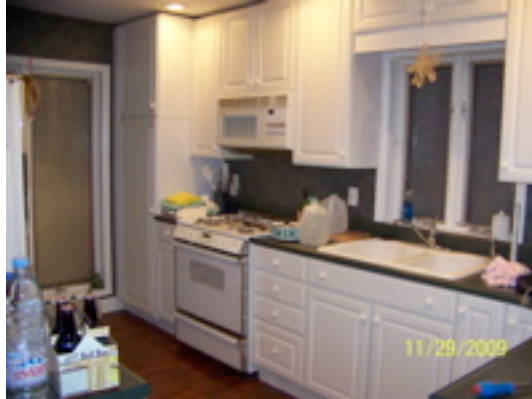
Kitchen comments & defective conditions

Concern: Garden hose attached at dishwasher drain running to unknown location behind cabinets presumably attaching to $\frac{3}{4}$ " copper pipe

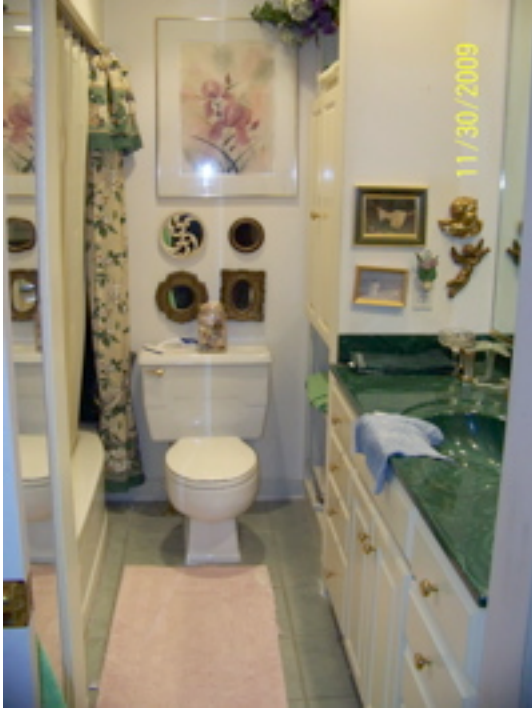
Bathroom #1 comments & defective conditions:**Defect:** no strike on jamb for pocket door lock to engage**Recommend:** install strike**Defect:** flat paint used on wall/ceiling in tub surround, can lead to mold growth and wall deterioration, only partially painted**Recommend:** repaint using semi-gloss paint**Bathroom notes**

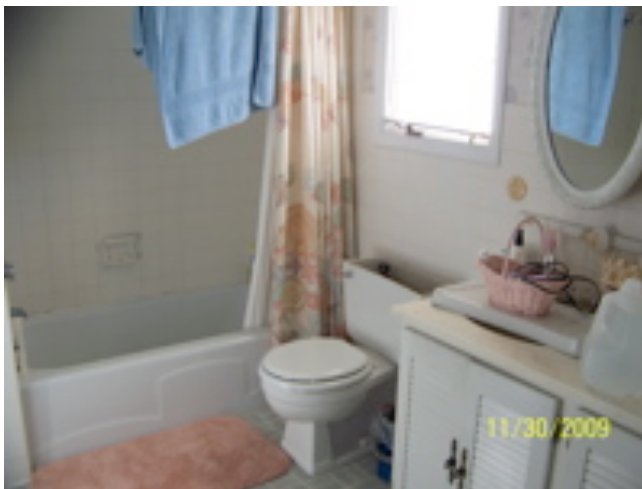
Bathroom #3 comments & defective conditions:**Defect:** drywall crack along ceiling**Recommend:** tape and sand ready for paint**Defect:** deteriorated and open caulk in tub enclosure**Recommend:** remove old caulk, clean surfaces, apply new silicone caulk**Hazardous Defect:** un-protected outlet strip above sinks**Recommend:** remove or install GFCI protection, consider removal, changing switch set-up to install GFCI outlet at wall switch location**Defect:** top of linen closet doors bind at jambs**Recommend:** plane top of doors for proper fit

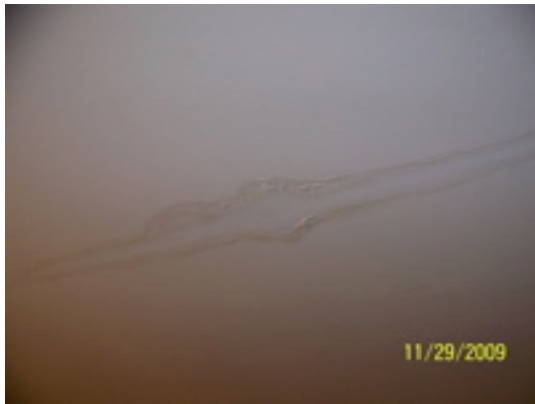
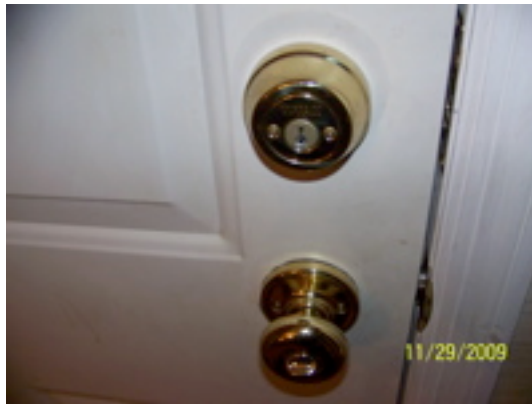
1st Floor rear family room comments & defective conditions:

Defect: drywall damage and staining along ceiling from apparent water leaks

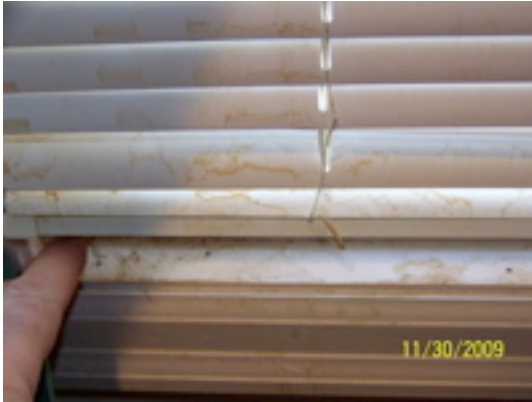
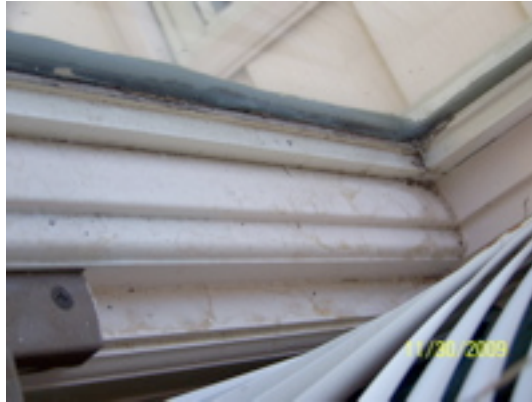
Bedroom #1 comments & **defective** conditions:

Defect: wall and ceiling crack running across length of room

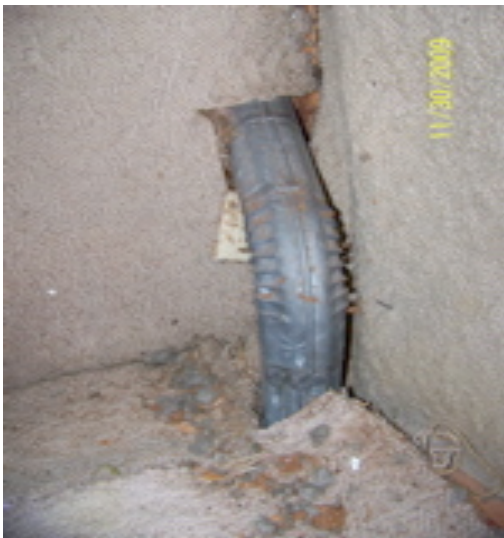
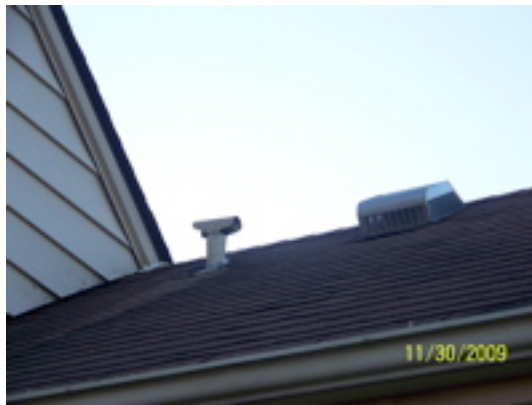
These pipes may be the flue vent for the fireplace. If so, this pipe is **NOT** suitable for fires. **DO NOT** use.

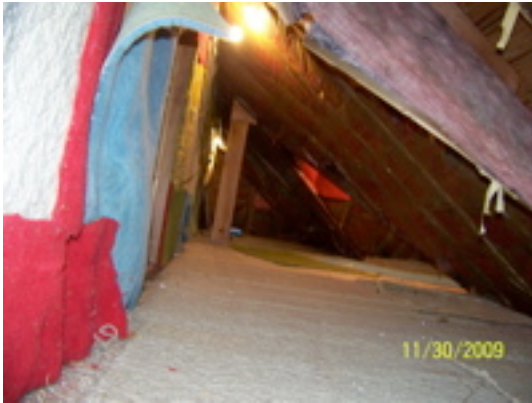
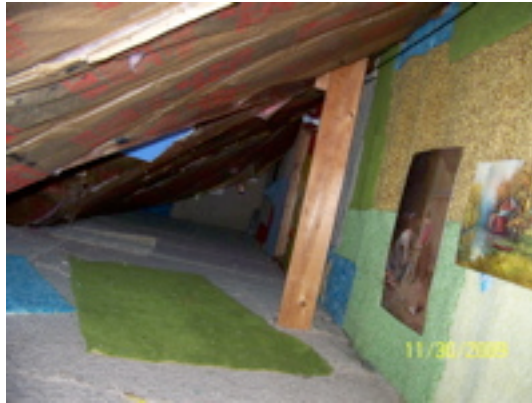
Interior comments & **defective** conditions:

Defect: 6" duct in knee wall connected to exterior, open at interior

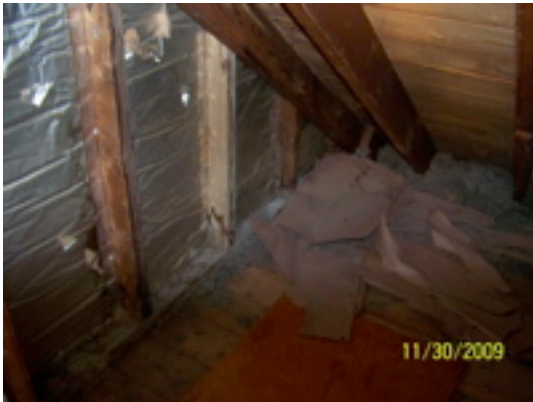
Attic comments & defective conditions:

Defect: poor older insulation at bedroom knee walls

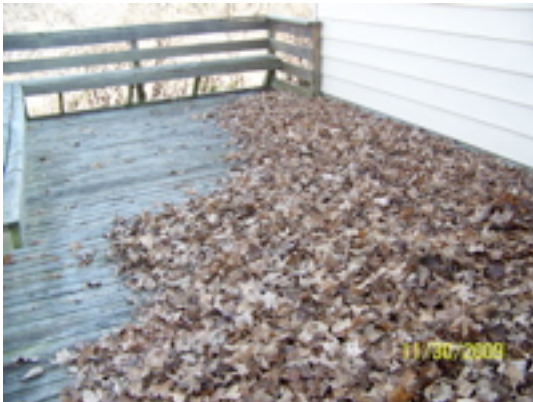
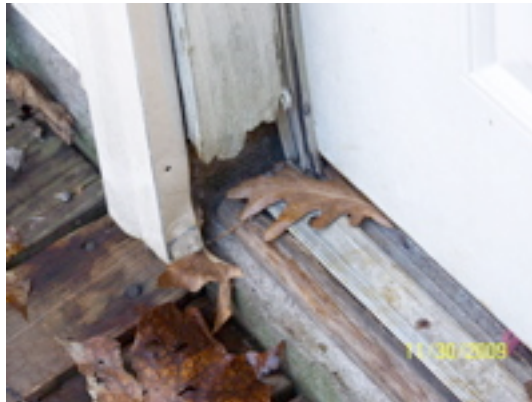
The wood rear deck is older and in overall fair to good condition. Repairs could be made to improve longevity and appearance. Cleaning and staining would help get a few more years of use out of the deck before replacement is really needed. The split joist should be repaired or replaced.
