# HOME INSPECTION REPORT

123 Chicago St.  
Somewhere, IL

Inspection Date: 1-1-00

Prepared by:  
Markus Keller  
**Accurate Inspections & Consulting**  
**(773) 844-4AIC**  
Chicago, IL, 60643

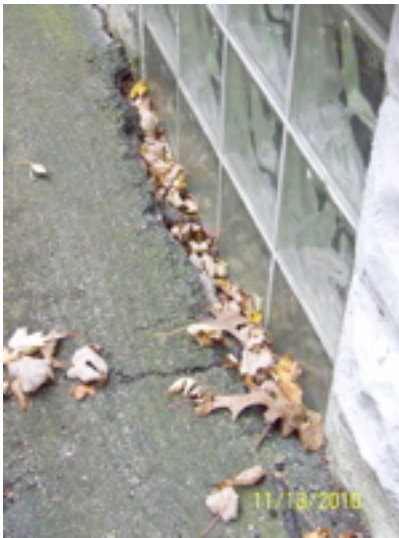
**Defect:** The north driveway sits ~ 5" above the bottom of the basement windows. The driveway should sit below the bottom of any windows and the top of the foundation. The current condition virtually guarantees the basement will take in water.

Driveway above bottom of window and top of foundation

**Recommend:** Due to the erosion of the driveway, replacement is needed regardless of elevation. Replacing the driveway will be very expensive for several reasons. At least 12" + of asphalt and soil need to be excavated in order to bring the driveway to proper grade. Proper drainage, soil bed preparation, slope and material usage should all be taken into consideration. Additional costs will be incurred to deal with either lowering or de-commissioning the catch basin. This will not be an easy project. I suggest you consult with a qualified architect when considering driveway replacement options. Most villages also have specific drainage criteria that must be met for permit approval. Consult your municipality.

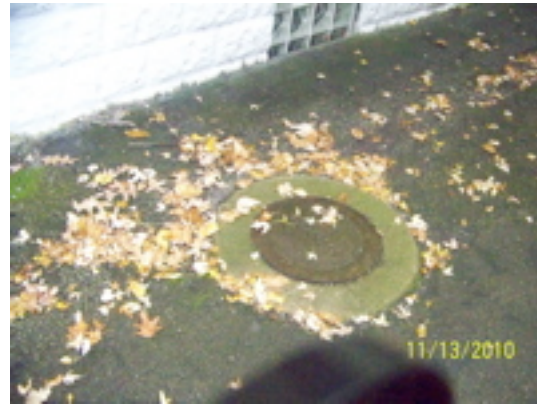
Eroded driveway and catch basin

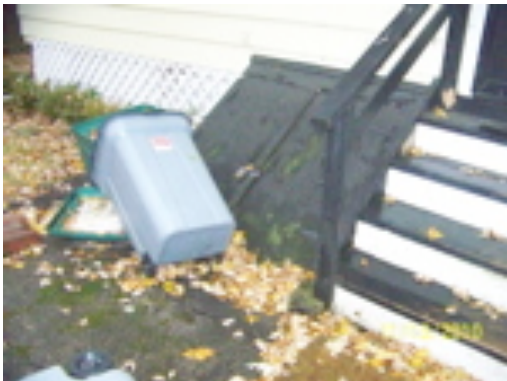
High driveway pad grade  
And rotted door

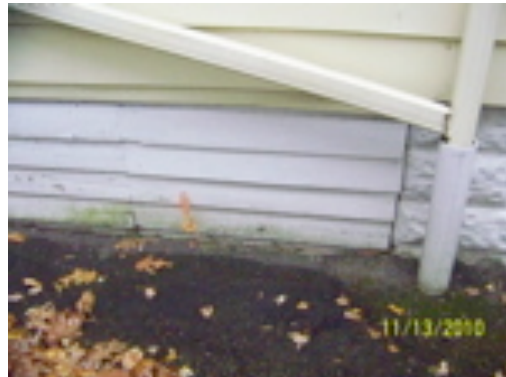
High driveway and rotted  
wood siding

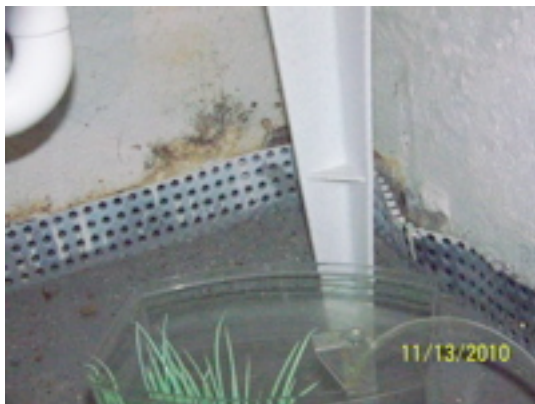
Northeast corner water intrusion

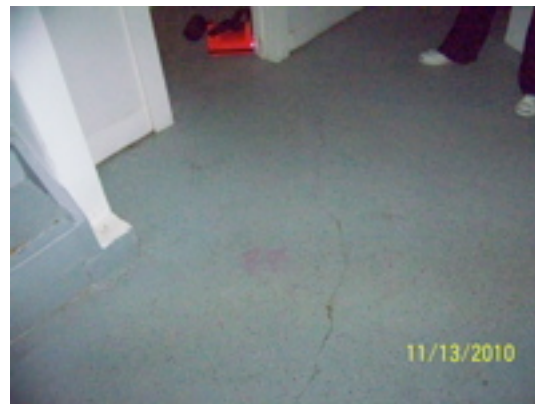
**Defect:** Multiple cracks in basement concrete floor. Some cracks appear age typical; some appear to be due to potential sewer problems

cracked, heaved floor at bottom of basement stairs. Likely due to sewer tile failure

**Recommend:** repair as necessary

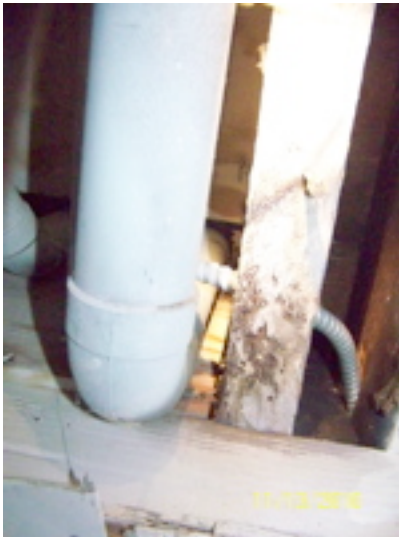
Rotted, twisted joist

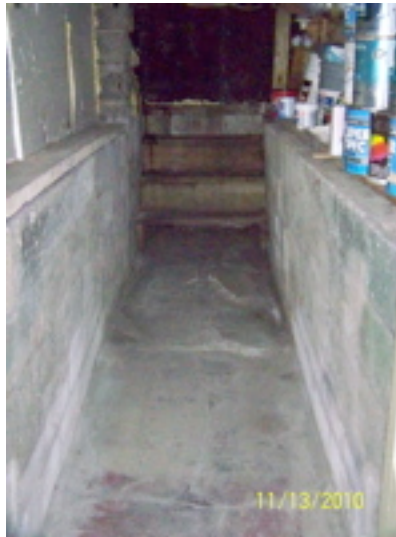
**Hazardous Defect:** rear basement egress retaining walls, leaning in, blocks shifted and out of alignment, mortar erosion and block damage; Leaning of the south wall will most likely continue over time, full collapse at some point is a real possibility

Rear retaining wall severely crack, eroded  
Separated and leaning in 1.25" +

**Recommend:** consider removal and replacement

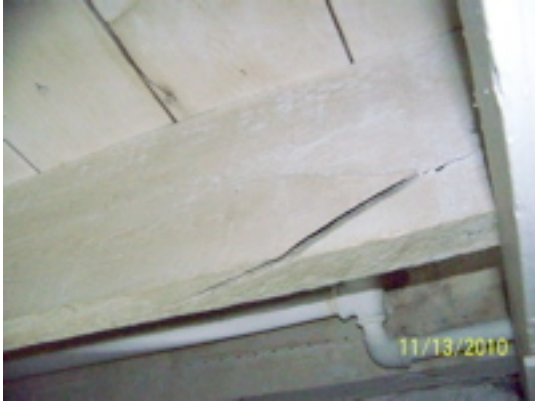
**Defect:** Broken joist to east of chimney, rotted joist ends and poor connections at multiple joists west side of chimney, twisted and rotted joist next to furnace, rear side; multiple rot and water damaged joist areas throughout; rotted posts ends and beam

Broken joist, left of wash machine

**Recommend:** Proper replacement of all defective members by qualified carpenter

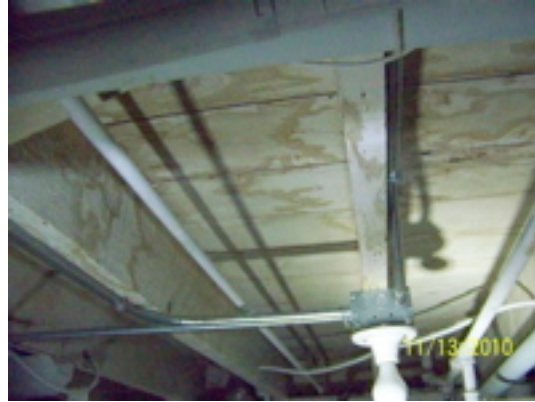
**Defect:** extensive signs of water exposure and damage at joists and subflooring along basement ceiling under kitchen

extensive water stains/damage  
At basement sub-floor and joists

**Recommend:** assessment and repair by qualified carpenter

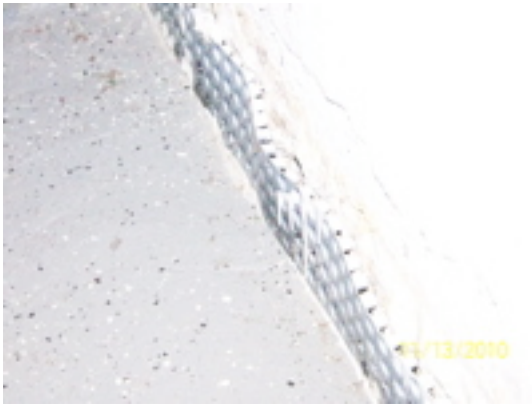
French drain along basement  
Foundation wall

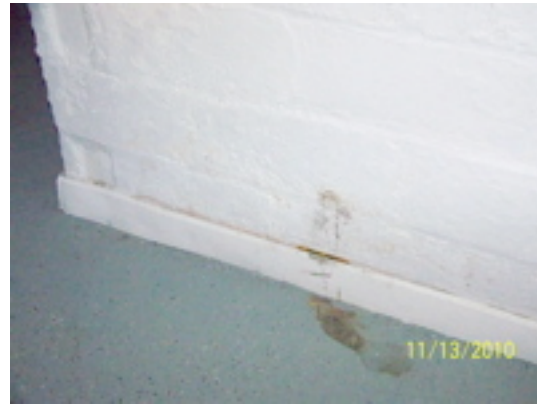
Signs of water intrusion,  
basement wall

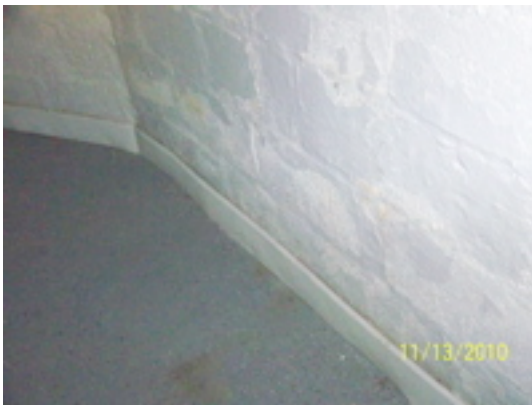
flaking paint and mortar along basement  
wall, typical of water intrusion

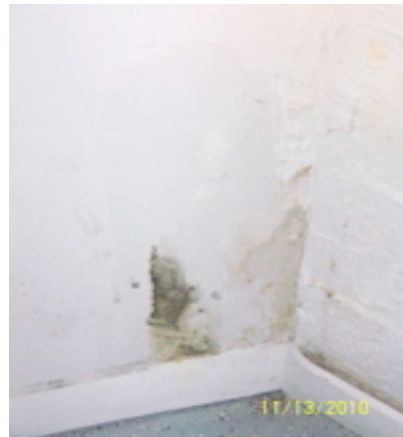
more signs of water intrusion

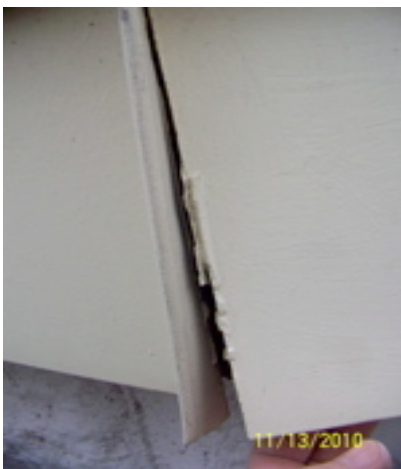
deteriorated siding condition

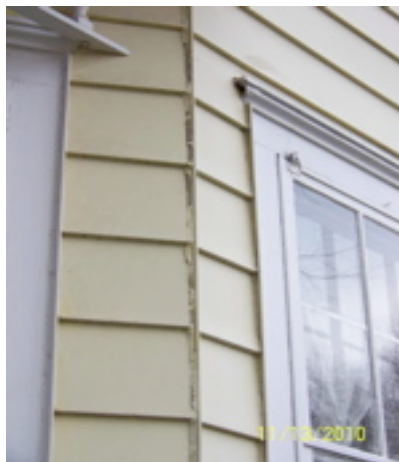
**Defect:** eroded caulk joints at siding seams, this condition tends to allow water to saturate the siding fiberboard backing and create moisture problems along the wall

poor caulk at joints

**Recommend:** clean joints and re-caulk as needed, consider installing new siding

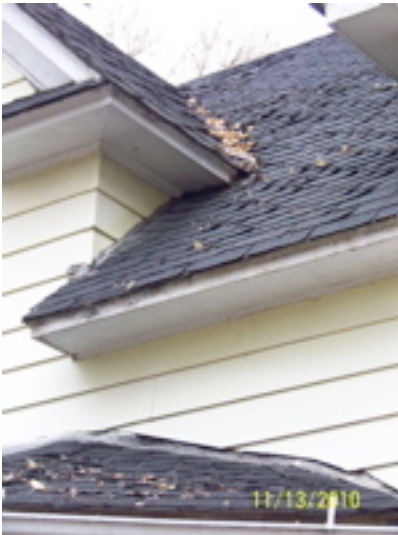
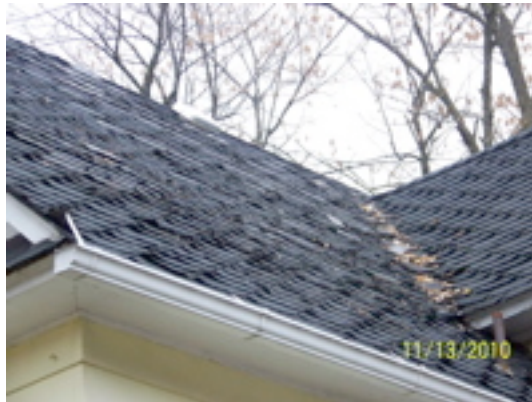
**Defect:** roof shingles deteriorated beyond further reasonable use, roof leaks

Deteriorated, curling roof shingles, front and rear roof areas

**Recommend:** full replacement

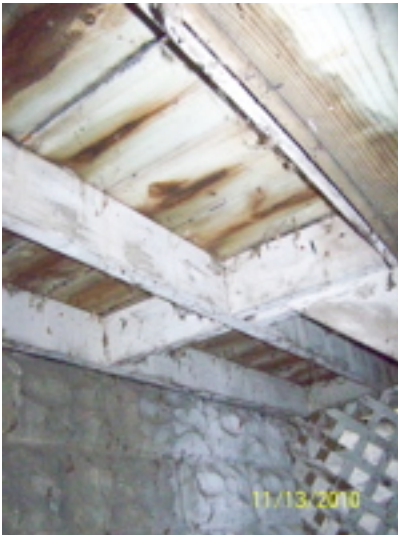
**Defect:** rotted wood framing at front and rear entry stairs and decks

Rotted framing for porch

**Recommend:** porches can be repaired but replacement will be needed at some point in the not too distant future, replacement would be a better option

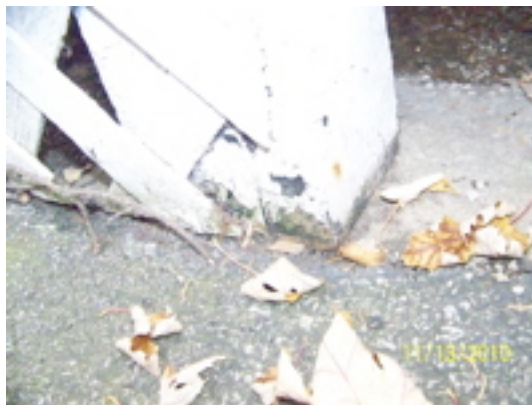
Rotted wood post base in contact with ground

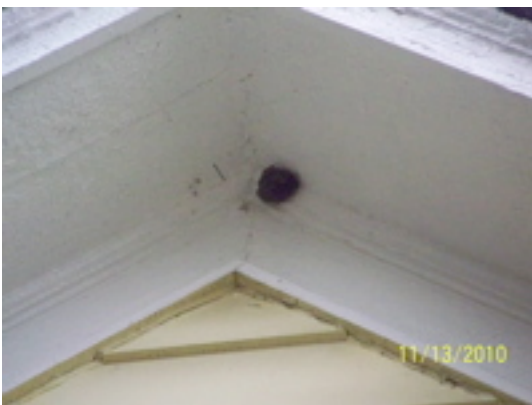
**Defect:** 2 wasps nests top of house

One of two Wasp nests

**Recommend:** remediation by qualified professional

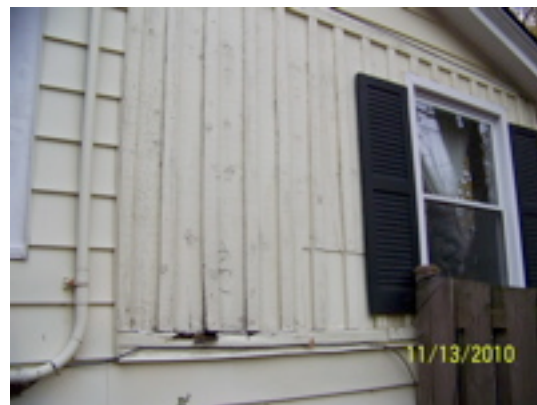
**Defect:** south wall of rear porch enclosure severely rotted out, structural damage, water seeping into wall

rotted out south wall

**Recommend:** remove all rotted materials and rebuild wall; This could be a very expensive repair job depending on how long the wall has been taking in water. There could be framing damage inside the walls that may need extensive or full replacement. Based on what is visible, full wall replacement may be likely.

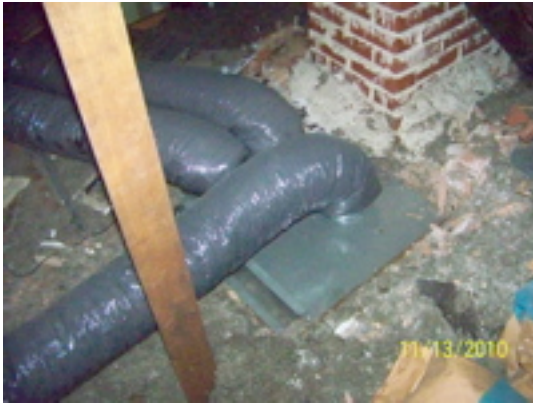
Attic duct runs, main chase and cover not insulated

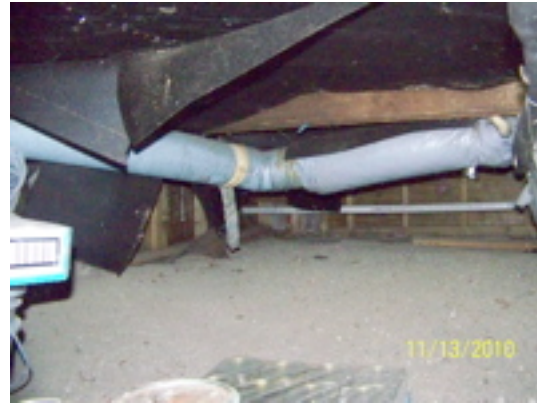
Un-insulated and not properly supported duct runs in crawlspace

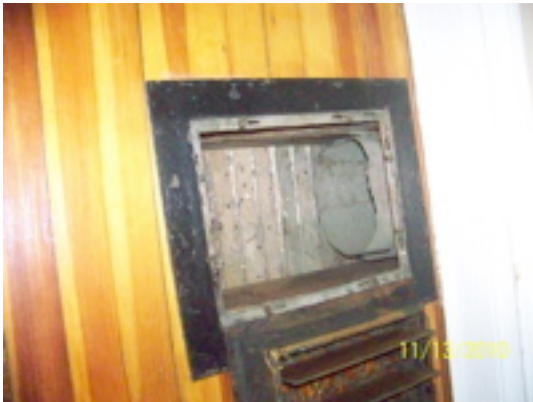
**Defect:** open ended duct runs without proper termination, un-insulated ducts in unconditioned space under rear porch enclosure and attic, ducts insufficiently supported

open ended duct run inside of joist cavity, substantial heat loss

**Recommend:** Proper duct and boot installations by qualified HVAC installer

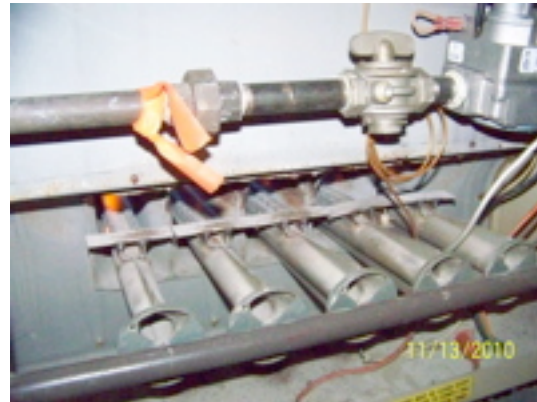
**Defect:** Older furnace, signs of rust at heat exchanger, gas valve has been modified and jumped for standing pilot, disconnected spark ignition wiring laying in furnace, motor wiring does not appear original

rusted furnace, jumped wiring

**Recommend:** at minimum assessment and repair by qualified HVAC technician, furnace replacement would be a better option

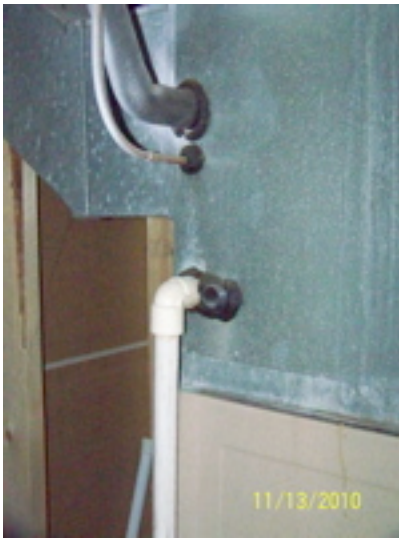
AC drain connection

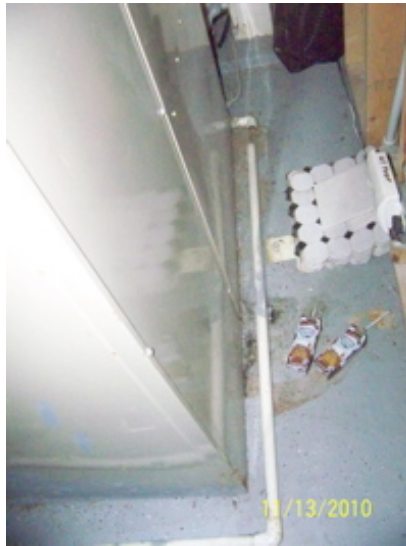
**Defect:** AC condensate PVC drain pipe broken, no air gap, trap or secondary drain installed at AC drain

AC broken drainpipe

**Recommend:** install proper drain assembly for AC condensate drain as per Manufacturer specifications

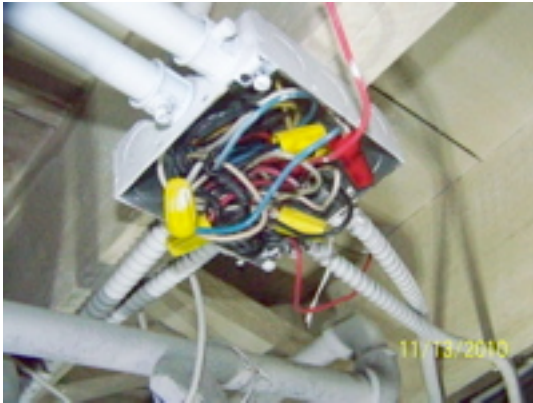
**Defect:** open electrical boxes, open wiring and wiring not properly terminated at various locations

Open electrical box

**Recommend:** Full repair by licensed electrician

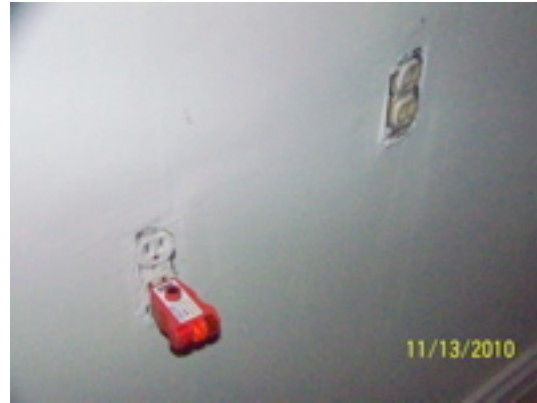
**Defect:** No covers on two receptacles behind refrigerator

no covers, mis-wired receptacle

**Recommend:** install covers

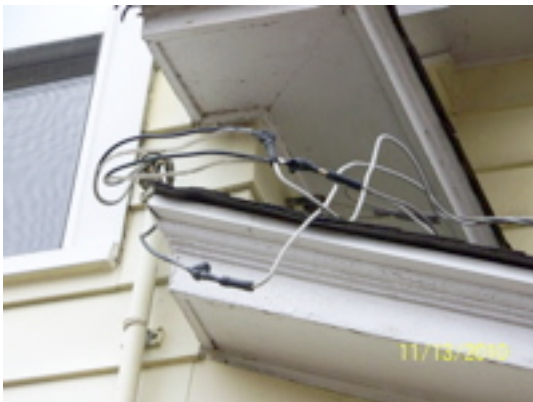
**Defect:** electrical service in partial contact with roof, reachable from window, installation may not be compliant or necessarily safe

electrical service in contact with roof

**Recommend:** consider assessment by licensed electrician

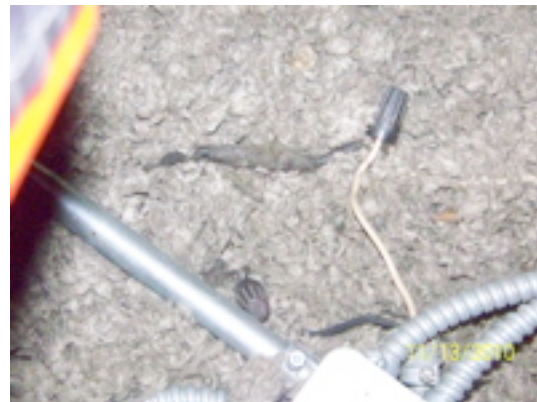
live knob & tube wiring

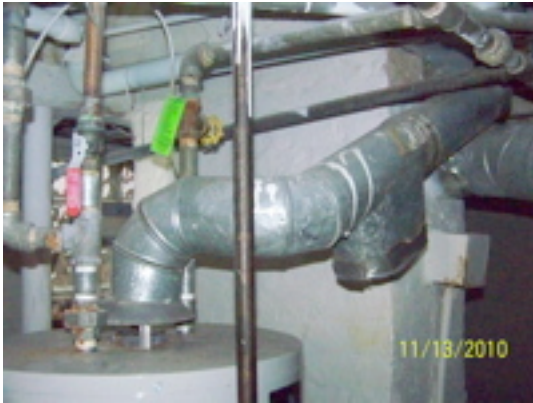
**Hazardous Defect:** improper flue pipe set-up for water tank, carbon monoxide can leak out of duct taped boot assembly, no 12" rise from hood prior to elbow

improper and hazardous flue pipe set-up for water tank

**Recommend:** install proper flue pipe assembly by qualified plumber

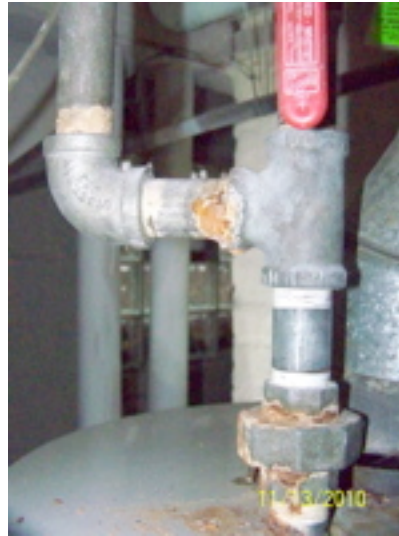
**Defect:** rusted galvanized pipe and fittings at multiple locations

rusted galvanized pipe and fittings

**Recommend:** consider removing all old pipe and replacing with new copper

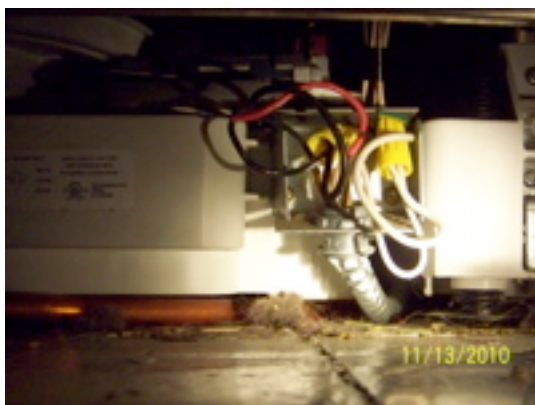
**Defect:** no cover on dishwasher electrical connection box

no cover dishwasher connection

**Recommend:** install manufacturer supplied cover on box, assess and secure wiring

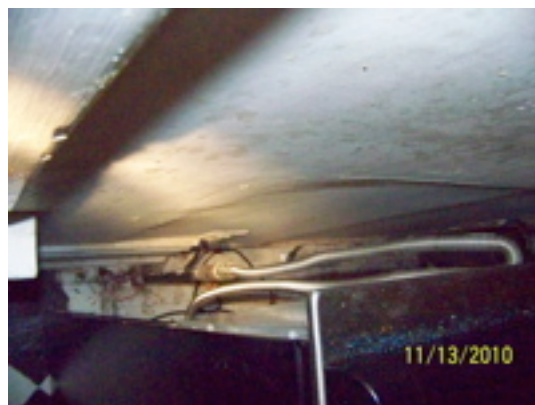
**Defect:** no gas shut-off valve behind stove to turn off gas

No gas valve or anti-tip bracket at stove

**Recommend:** install approved gas cock within reach of stove

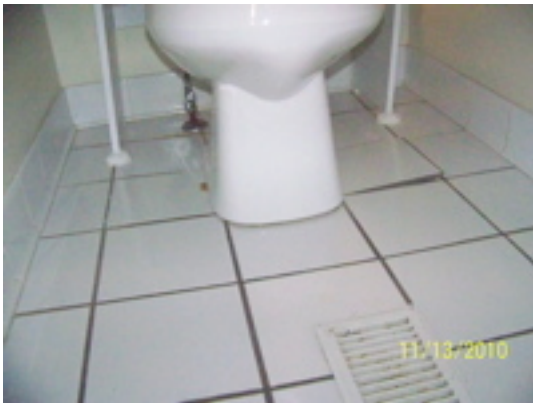
**Defect:** 2<sup>nd</sup> floor toilet sinking into floor, tiles popping up around toilet, extensive signs of water leaks on 1<sup>st</sup> floor ceiling under bathroom

2<sup>nd</sup> floor toilet sinking into floor  
tiles popping up

**Recommend:** open floor and ceiling as needed to assess and repair plumbing leaks, provide all repairs for daily use of bathroom

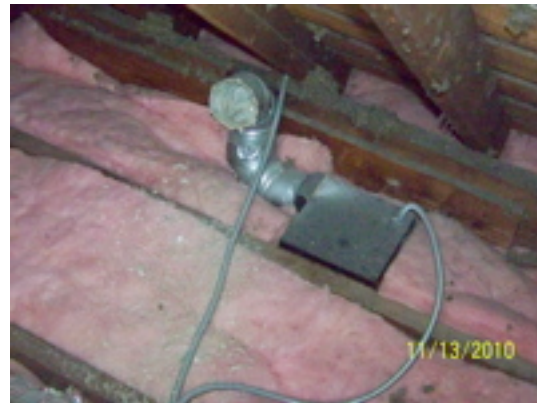
2<sup>nd</sup> floor bath exhaust fan vented  
into attic

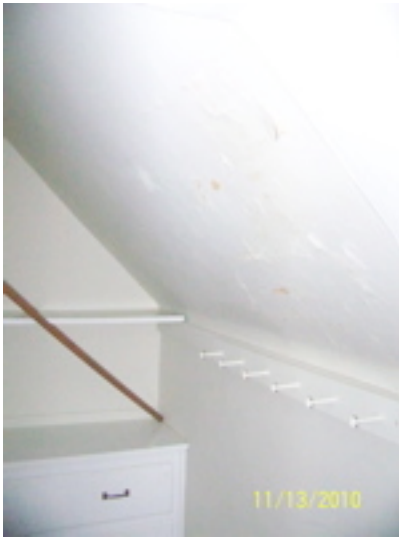
**Defect:** water damaged plaster at walls and ceilings in various areas of 2<sup>nd</sup> floor from roof leaks, in closets front wall of front bedroom, etc

Damaged plaster from water leaks  
2<sup>nd</sup> floor front closet

**Recommend:** repair as desired after roof replacement

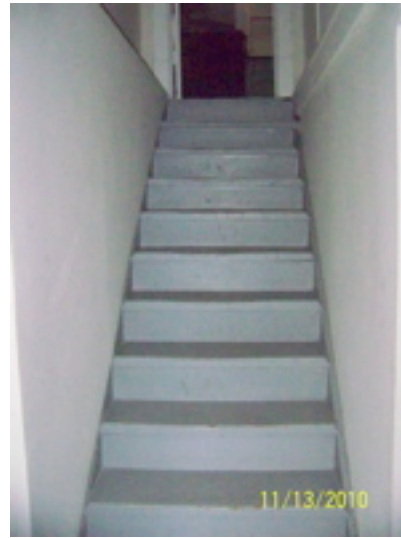
No handrail at stairs to basement

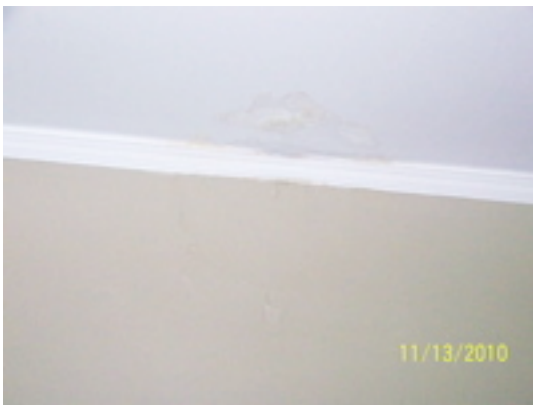
wall and ceiling roof leak damage

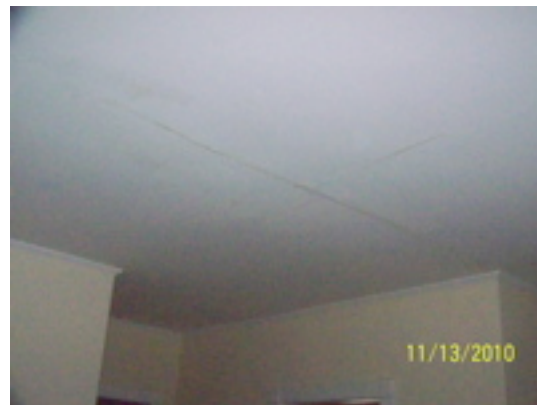
**Defect Concern:** Due to the amount of potential water leakage from the 2<sup>nd</sup> floor bathroom, 1<sup>st</sup> floor ceiling joists may need repair

1<sup>st</sup> floor ceiling, water damage

**Recommend:** remove ceiling during bathroom repair, assess joists and repair as needed

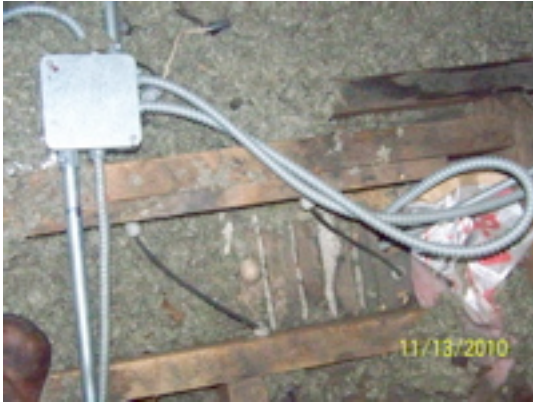
**Defect:** very poor and insufficient insulation in attic

Exposed attic wiring, poor insulation

**Recommend:** consider fully upgrading insulation type and levels to provide better insulation R value, increase comfort and reduce heating bills

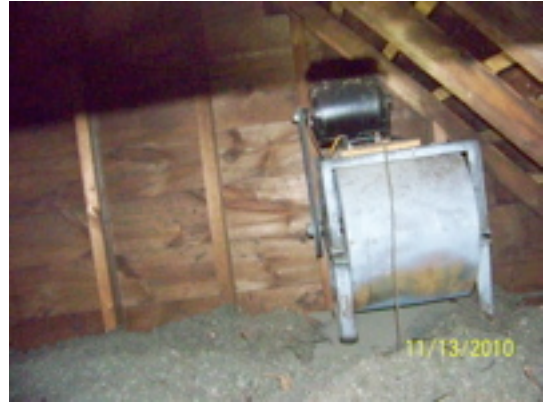
**Defect:** old electric exhaust fan assembly in corner of attic

old exhaust fan in attic

**Recommend:** removal as desired
