Property
Condition Report
For Bar / Restaurant

123 N. Chicago St.
Chicago, IL

Inspection Date: 1-1-11

PROPERTY CONDITION REPORT

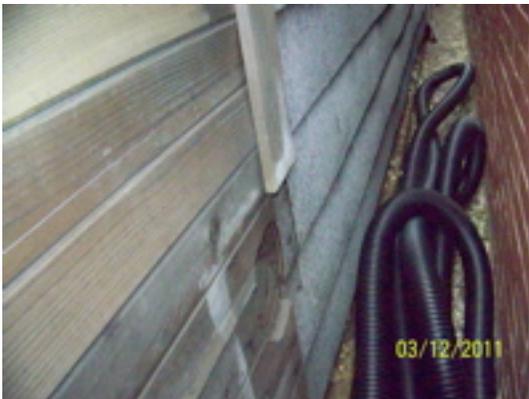
Defect: South downspout not extended to ground and outward with elbow. This allows water to dump directly along the foundation. North downspout run not complete, corrugated tubing not secured. Appears to be not properly sealed.

Gravel and corrugated tubing
Used for downspout

Recommend: Proper gutter and downspout installation to avoid water seepage. Water seepage along the north basement wall may be a combination result of poor grading and upper wall water intrusion leaching down

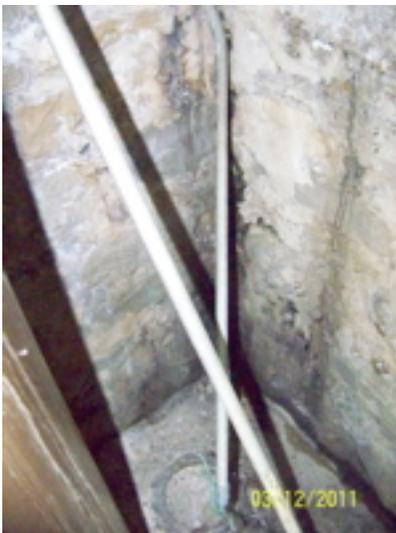
Typical wall seepage signs

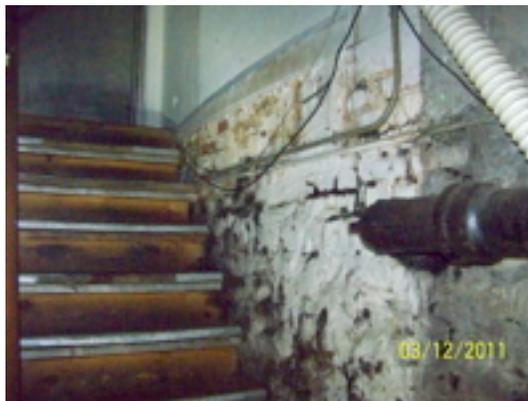
Concern: Gravel, grading and drainage appear to be an issue in the north gangway. There is essentially no place for water to go except down along the foundation wall. Extensive signs of water intrusion are evident along the north basement wall

Seepage and mold signs at north wall

Recommend: Installing a drainage membrane and grading to route water either to the front or rear to reduce seepage along the foundation wall

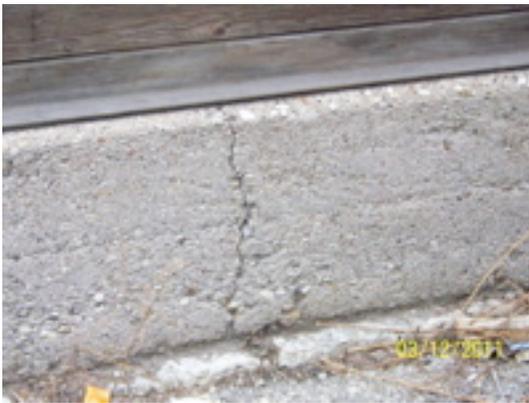
Defect: At least 17 foundation wall cracks counted along south wall, multiple cracks and bulging patch work at east wall

Typical foundation wall cracks

Recommend: have cracks structurally repaired by qualified mason

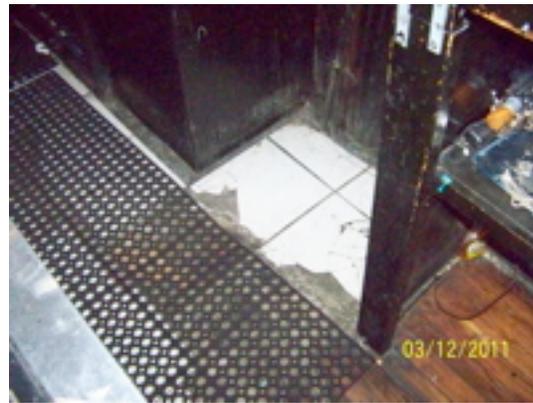
Defect: Extensive joist rot and sagging evident at 1st floor bar and visible in basement open drywall areas, this is likely due to water seepage; main room under 1st floor bar, water tank room, 2nd floor utility room at ceiling hole, at least 3 joists visible at water tank room

Rotted, unstable floor behind 1st Floor bar area

Recommend: remove drywall and fully assess and repair/replace joists

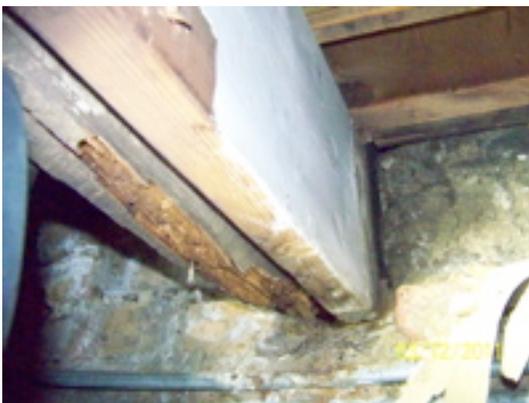
Typical rotted, un-supported joists

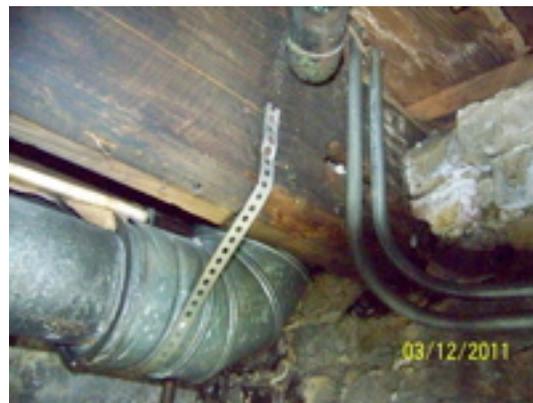
Typical rotted and cracked joists

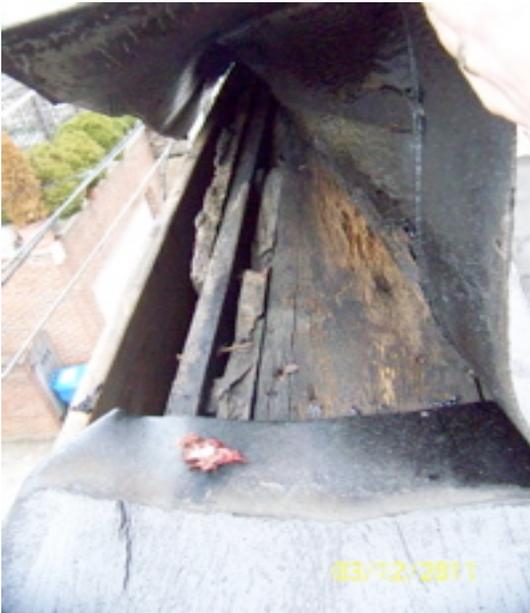
Defect: Possible perimeter wall framing deterioration and rot, top of 2nd floor roof parapets, wood clearly rotted out, extensive repairs needed

Top of 2nd floor parapet wall rotted out

Recommend: full assessment and repair by qualified carpenter

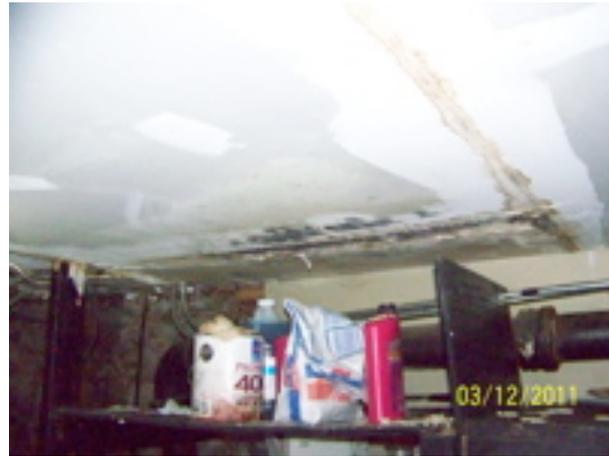
Basement ceiling water damaged drywall and joist damage

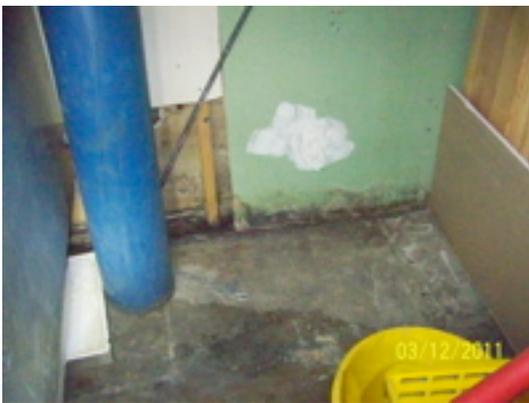
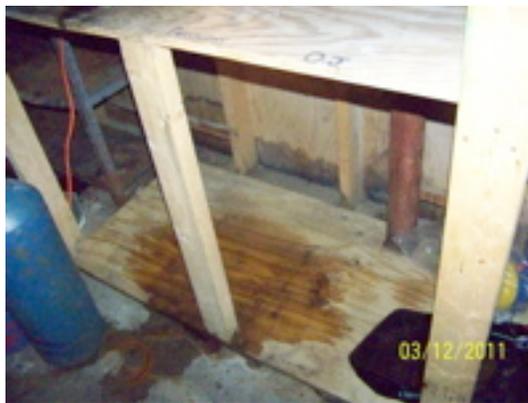
Typical water damage in basement and active water leak

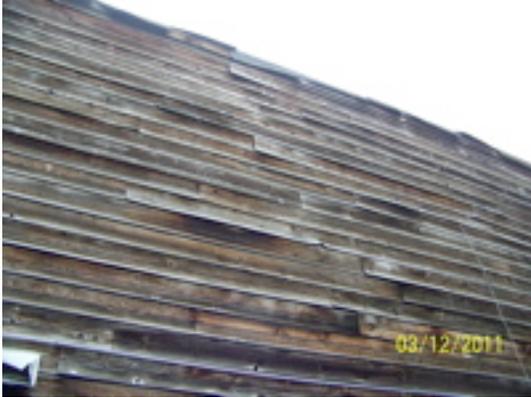
Top of south wall, rotted and open

Recommend: Consider removing all existing materials and installing new substrate, insulation and siding. It is likely that needed framing repairs will become visible once siding is removed; proper repair by licensed Contractor

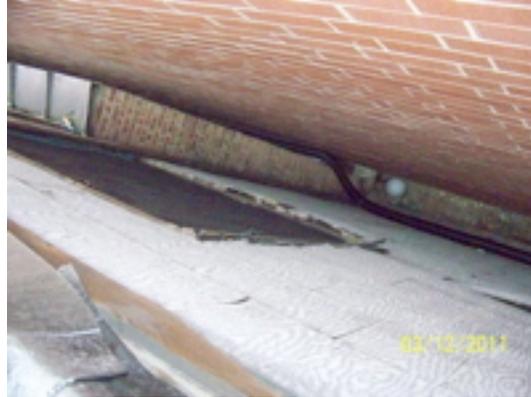
Open and broken areas on north wall

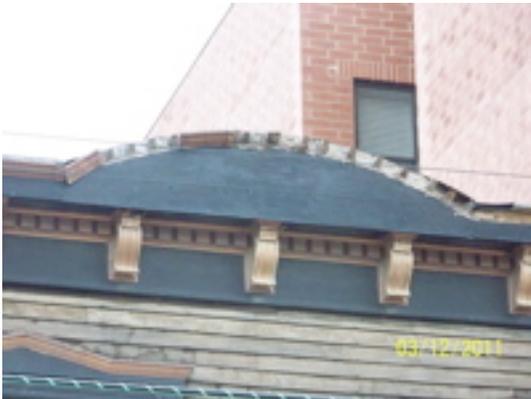
Defect: Rotted and missing trims at window locations, top of east wall and various locations, multiple holes in north wall

Top of east wall, missing, rotted trims

Recommend: replace all rotted and missing components, proper repair by licensed Contractor

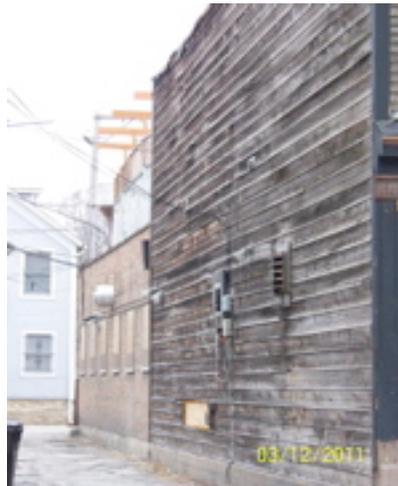
Defect: Exterior wood and asphalt siding rotted and damaged with numerous holes, north, south and east elevations. This is clearly allowing water intrusion into the building and rotting to exterior wall framing

Main south wall, rotted and open

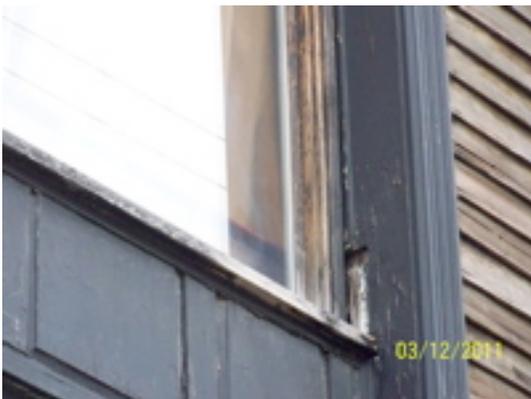
Typical wood rot at windows

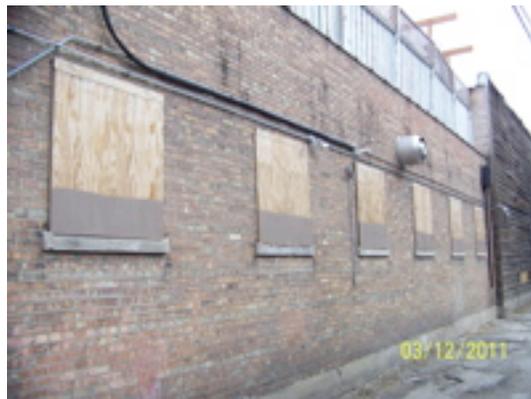
Defect: Exposed plywood and water saturation at south wall window board up. Top piece of plywood clearly taking in water. No flashing, caulk or water impervious materials visible. Water may be infiltrating behind plywood and causing wall damage around windows.

Rotting plywood at boarded windows

Recommend: Install flashings at top of plywood, cover with water impervious materials or replace board up; proper repair by licensed Contractor

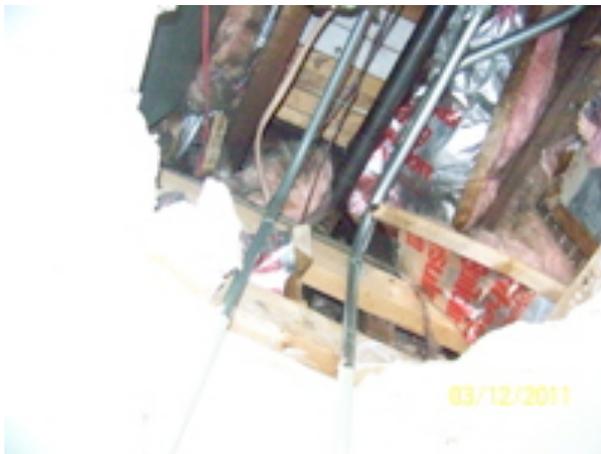
Open ceiling to roof at 2nd floor utility room ceiling

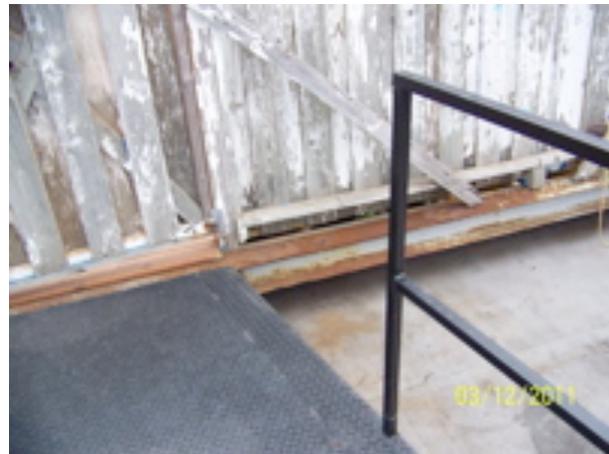
Missing guardrail, 2nd floor egress

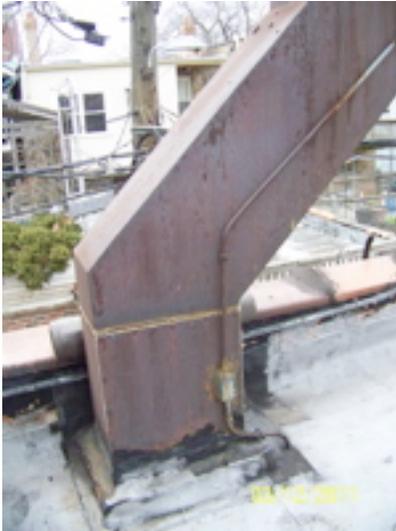
Defect: Kitchen exhaust hood duct work rusted at roof area

Rusting duct for main
Kitchen exhaust hood

Recommend: clean, prime and paint to reduce further rusting

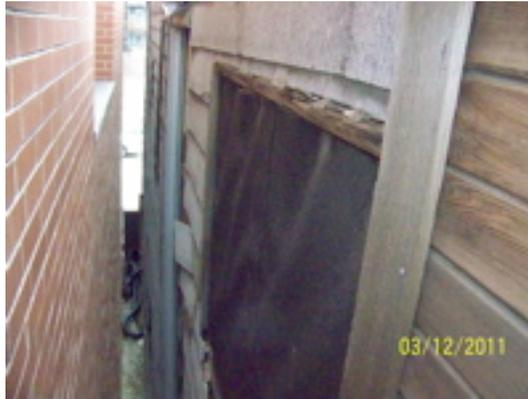
Open north wall allowing water
intrusion

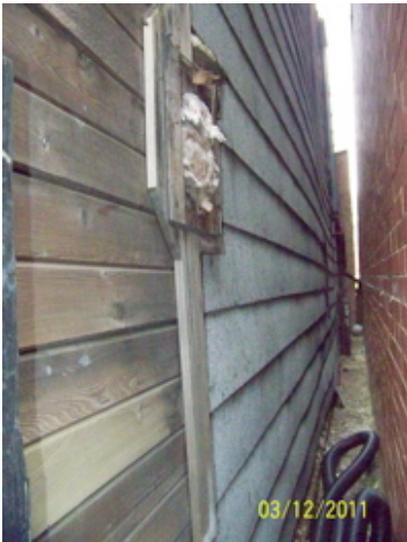
Hole in north wall, poor siding

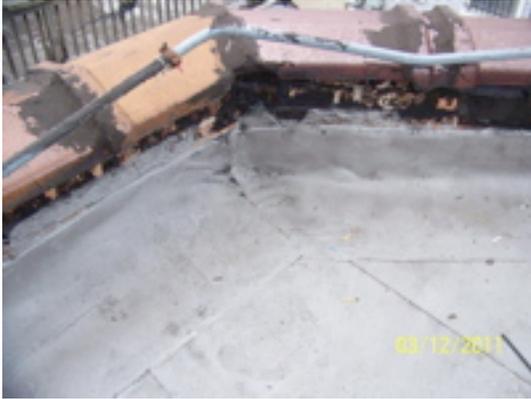
No term bar for roofing at parapet

Recommend: monitor joints and consider installation of term bars; 1st floor roof appears to be in newer, good condition with no signs of leaks

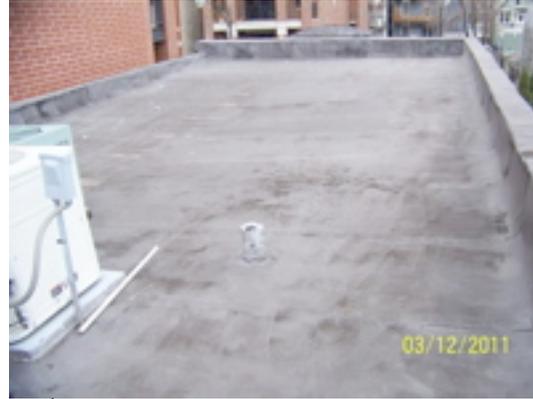
2nd floor roof field

Defect: 2nd floor roofing material – loose, un-attached roofing material along parapet walls, deteriorated flashings at all roof penetrations, poor seams at some locations, signs of roof leaks at 2nd floor ceiling

Recommend: repair or replace roof as desired by licensed roofer

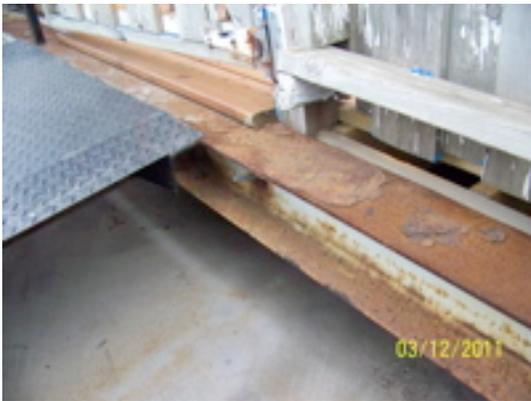
Defect: Signs of rusting at roof top steel support I-beams; As a repair this is fairly inexpensive, as a replacement because repairs weren't performed it is a costly job.

Rusting I-beam for deck support

Recommend: clean, prime and paint to reduce further rusting as soon as feasible by qualified Contractor

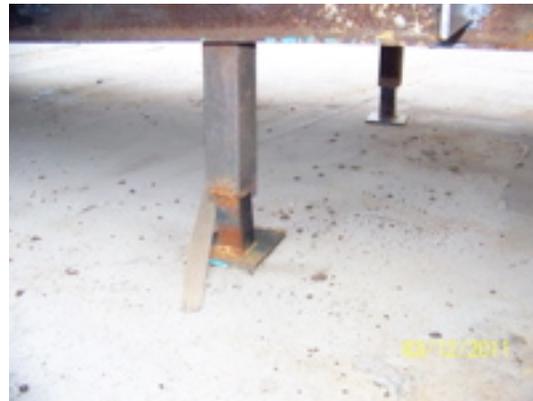
Defect: 2nd floor steel egress path legs sitting directly on roofing material. This can lead to premature material deterioration and leaks due to vibration and movement.

Walkway feet sitting directly on Roofing material

Recommend: Consider installing approved isolation pads, proper repair by licensed Contractor

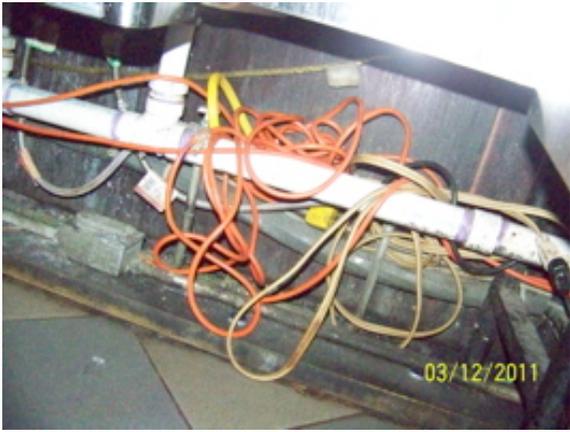
PVC drain pipe and extension cords

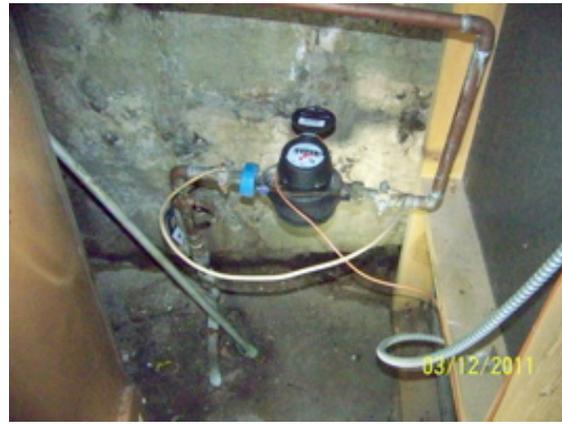
Defect: Lead water service is crimped at floor level due to lack of support, water meter and meter spreader not attached or supported. The combined weight can continue to bend the lead pipe at the floor until water can no longer flow through
NOTE – this size service is unlikely to load calc out for the existing fixture units. I would recommend budgeting for future new water main installation

Water main and meter

Recommend: Immediate compliant repair by licensed Plumber

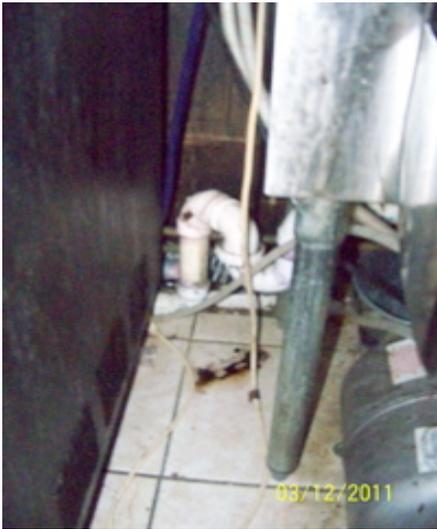
Defect: Non-compliant PVC drain lines in commercial space – 2nd floor bar sinks, 2nd floor urinals, 2nd fl. floor drains, 1st floor rear bar, 1st floor rear station sink, inside bathroom ceilings

PVC drains at bar sinks

Recommend: Compliant replacement by licensed Plumber

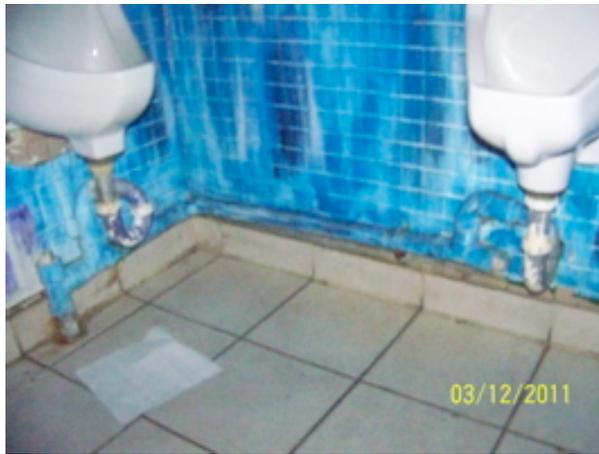
PVC drains at urinals

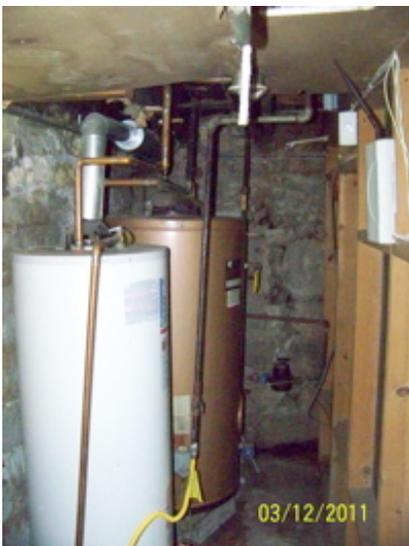
Defect: Attached water tank did not fire-up during hot water demand even though pilot light and knob were both 'ON'. Temperature knob set to full "HOT" setting. This tends to be an indicator that the tank is at the end of its useful life cycle. 50 gallon capacity is unlikely to load calc out for the amount of fixture units, especially if a dishwasher unit is installed, TPR pipe not low enough

Water tanks, rear unit not functional

Recommend: installation of a properly sized new water tank by licensed Plumber

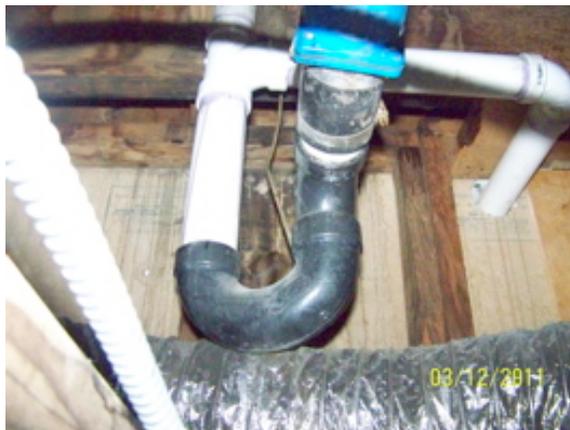
PVC and ABS drain pipe, and check valve in bathroom ceiling

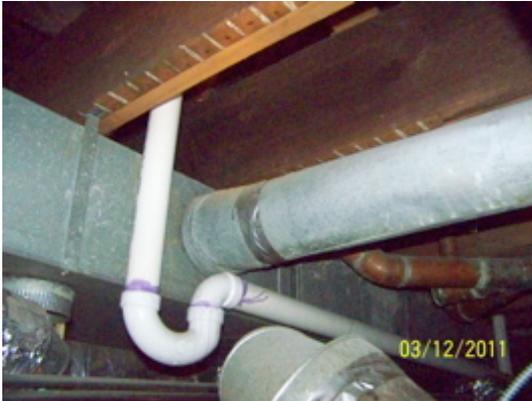
2nd floor PVC floor drains

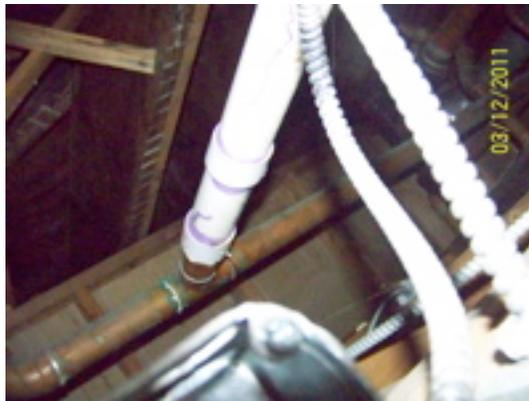
PVC drain tied into copper run

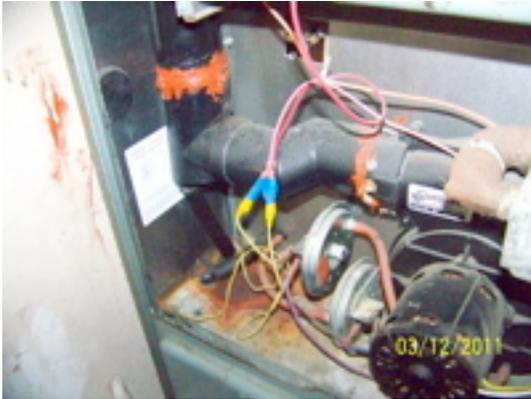
Defect: Interior of unit very dirty, blower motor covered with dirt, unit pulling return air from within closet, this creates negative pressure and can affect combustion; rust and water damage inside of unit from leaks, poor vent motor replacement work, unit does not function via thermostat

1st floor front furnace, water damage and rust at unit cabinet

Recommend: full clean and check service, proper repair by qualified HVAC technician

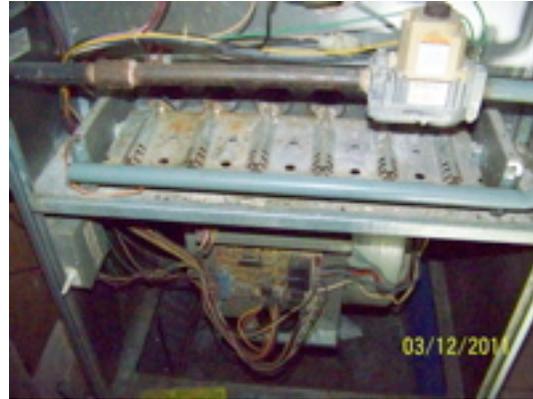
Dirty 2nd floor furnace

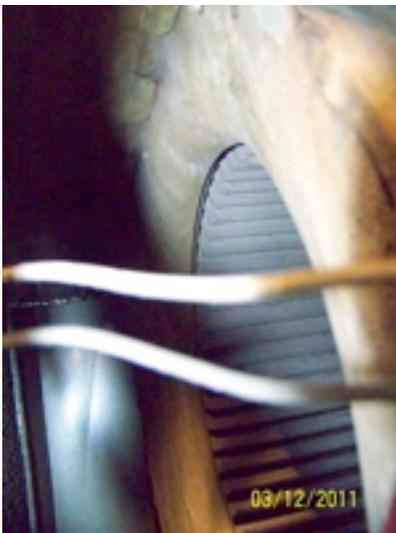
Dirty blower motor

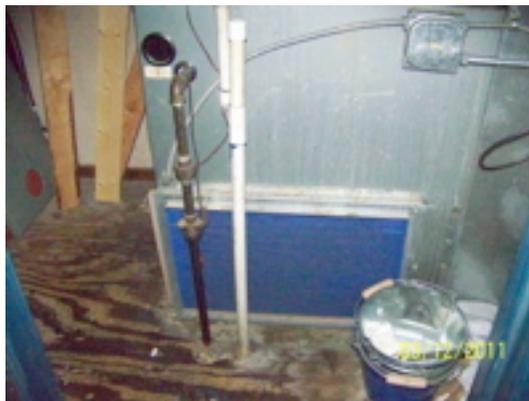
Unit pulling return air from furnace closet

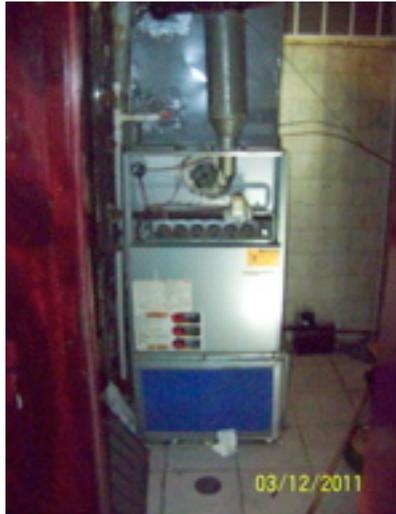
Defect: Interior of unit very dirty, blower motor covered with dirt, unit pulling return air from within closet, this creates negative pressure and can affect combustion; return filter located directly in front of floor drain,

2nd floor unit, pulling return air from closet and in front of floor drain

Recommend: proper repair by qualified HVAC technician

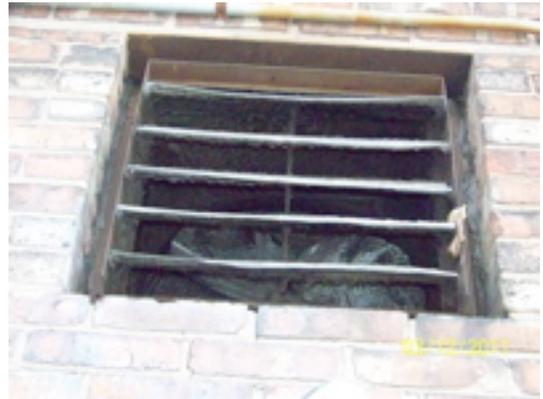
Typical through wall fan
Vaner do not close fully

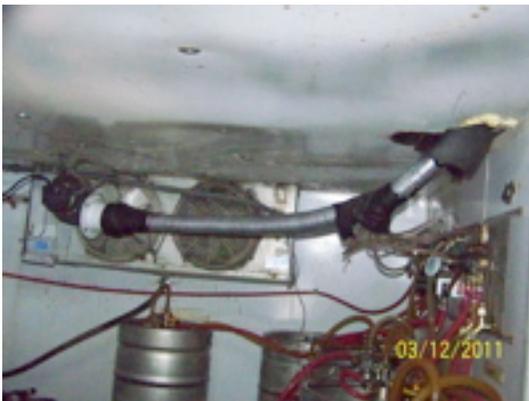
Homemade AC to 1st floor beer tap station

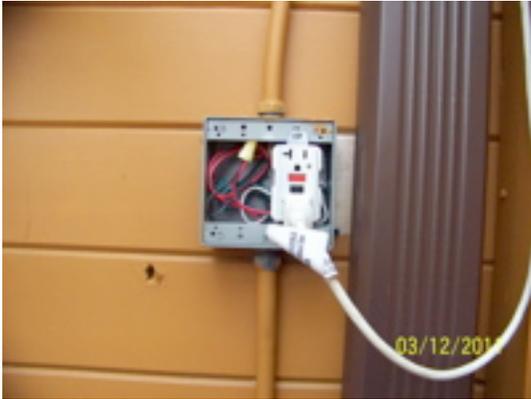
Open exterior electrical box

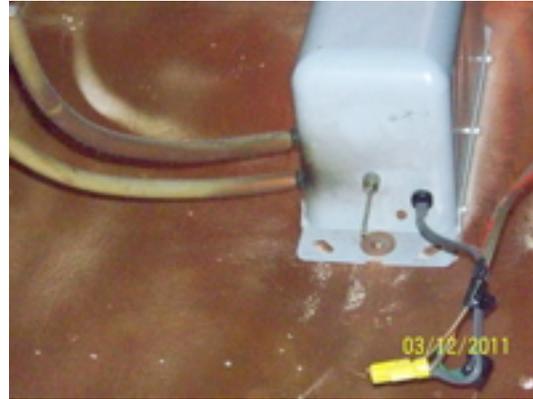
Scorched wires at transformer

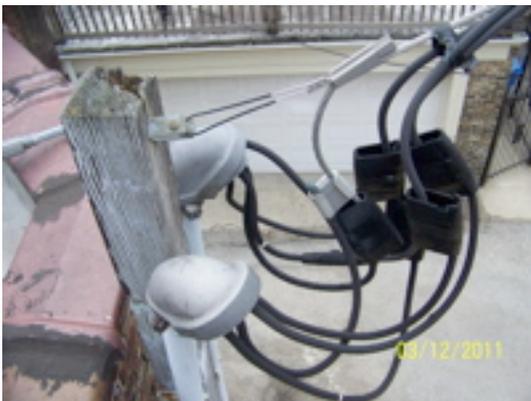
Service within reach of stair landing

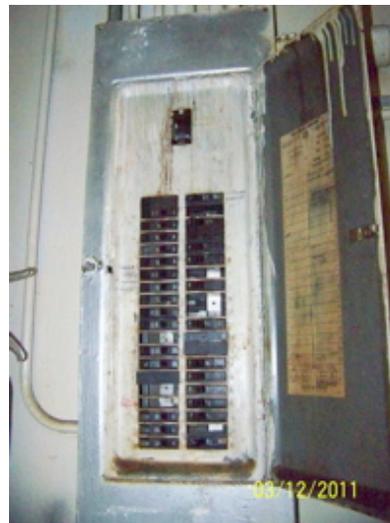
1st floor panel, open slots

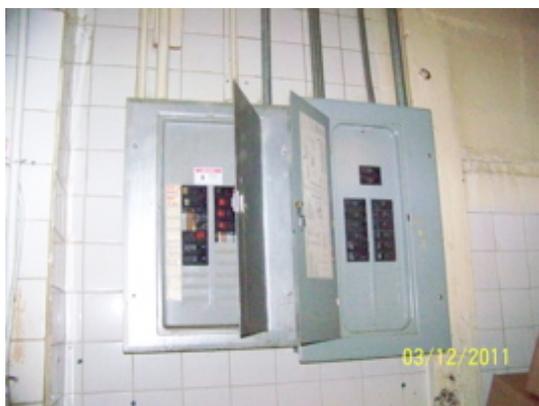
1st floor panels, not labeled

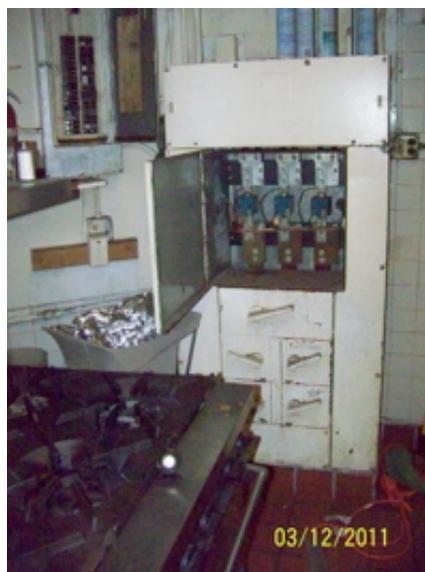
Live buss, main switchboard
1st floor kitchen

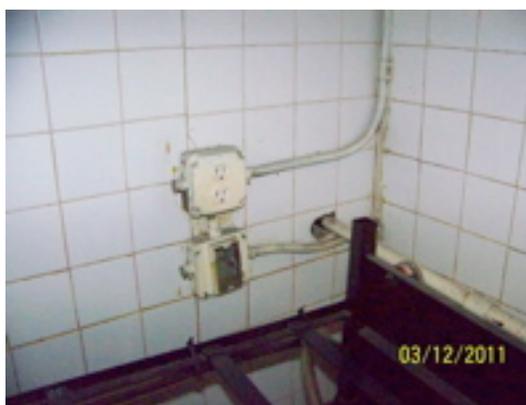
Open box, no GFCI, kitchen

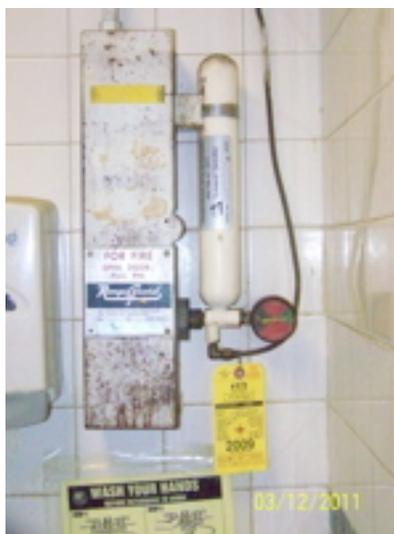
Outdated tag on fire suppression system

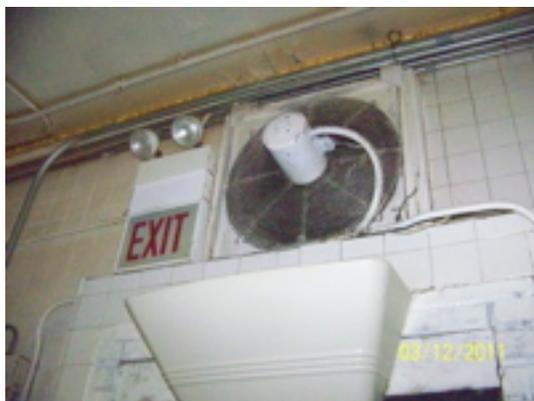
Kitchen exhaust fan, dirty
Leaking air

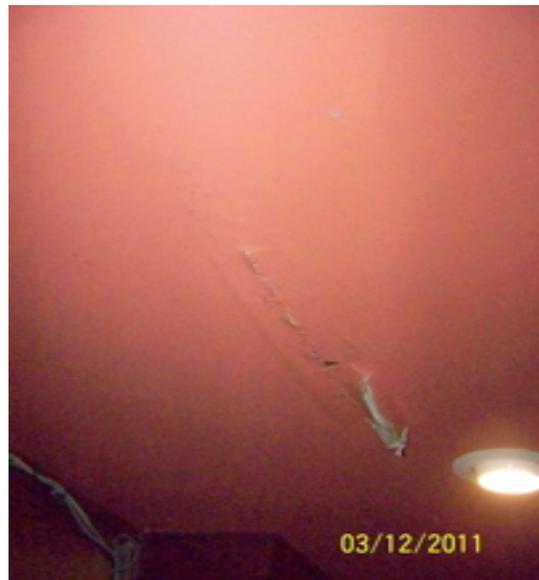
2nd floor ceiling roof leak signs

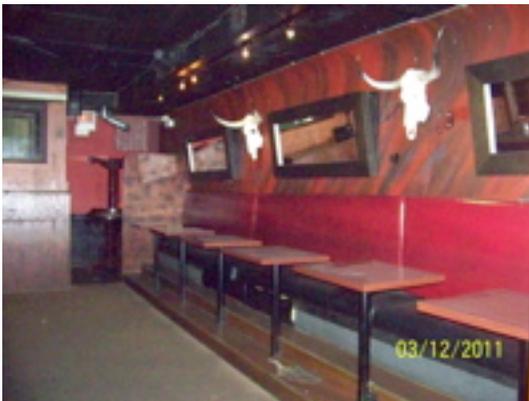
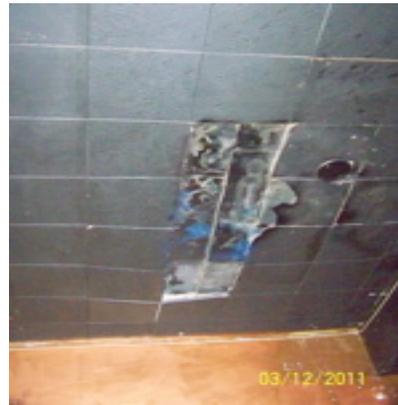
Damaged seating area and hanging ceiling tiles, 1st floor rear bar area

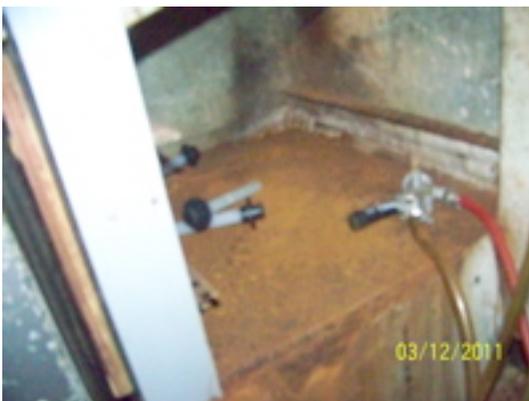
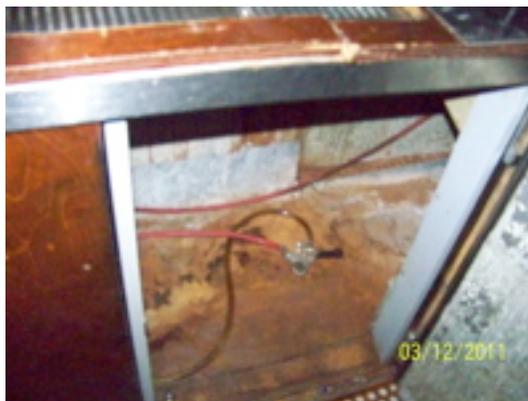
Typical rusted out bar coolers, 1st and 2nd floors

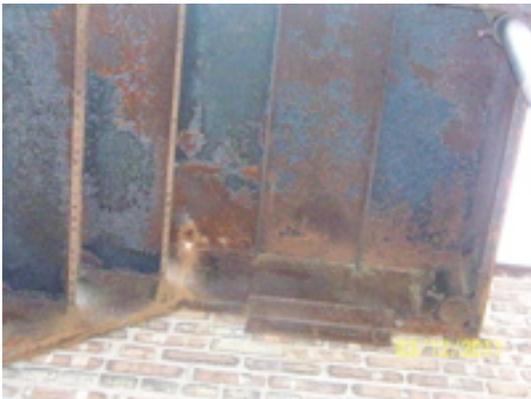
Defect: rear steel staircase and components very rusted

Extensive rust at rear steel staircase

Recommend: immediate repair to avoid further deterioration by qualified contractor

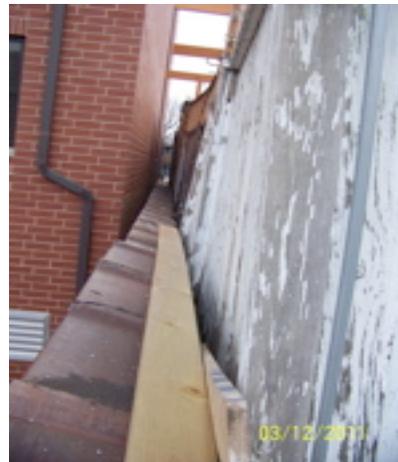
Rotted and leaning walls
At 2nd floor deck

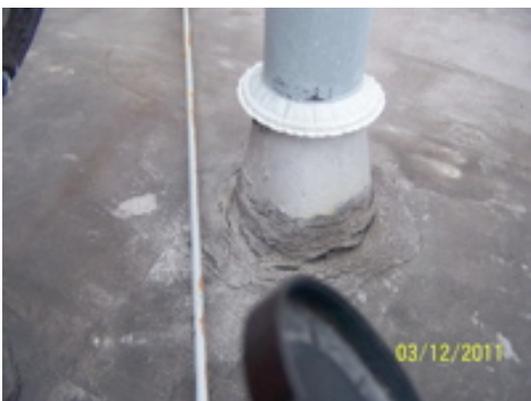
Typical deteriorated vent flashing
