HOME INSPECTION REPORT

123 21st Ave.
Somewhere, IL

Inspection Date: 1-1-00

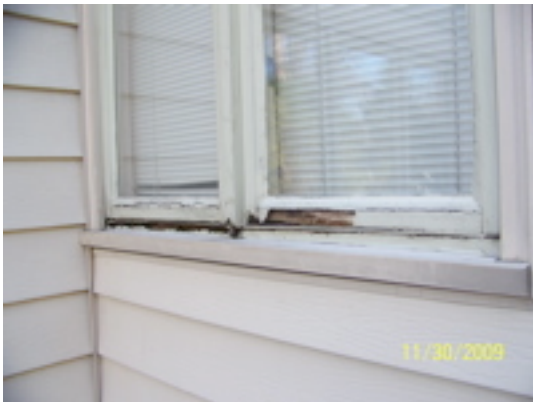
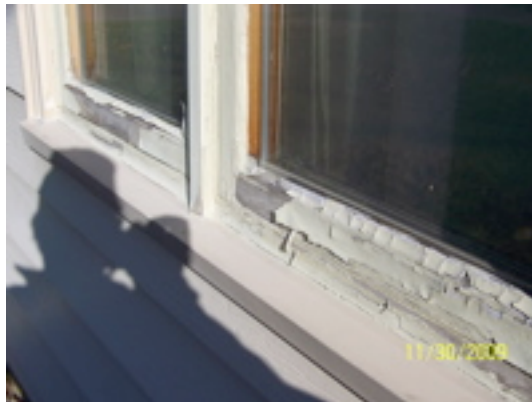
Very poor, rotted, open

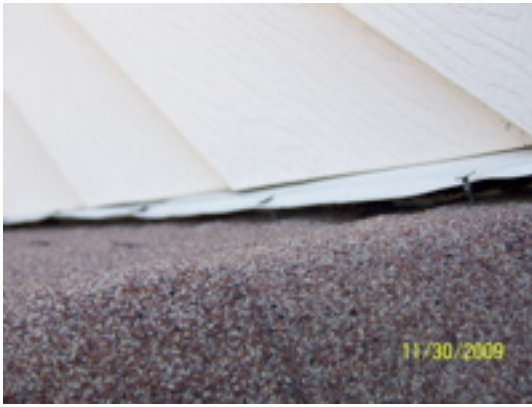
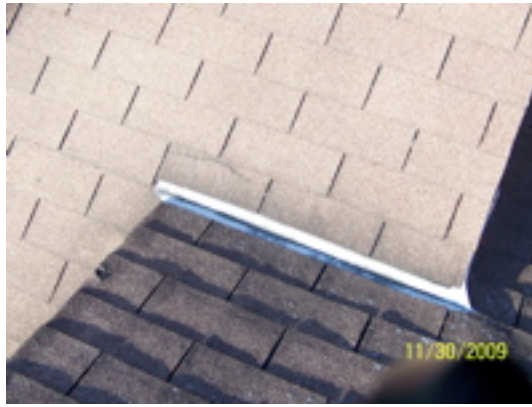
At valleys:	questionable
At chimney:	detached and loose at vent pipe
At eaves:	detached and open

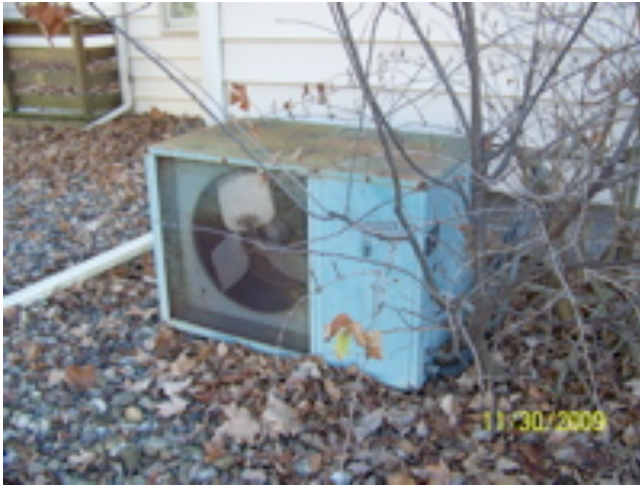
AC equipment	Y/N	OK	Defective	Repair	Comments
AC #1					
Central AC	Y				
AC working during inspection	N				Too cold to operate
Did space come down to set temperature?	NA				
AC brand					Williamson
AC Model #					7420-03-2036
AC size					3 ton
SEER rating					Probable 8 or less
Electrical					
Disconnect near unit?	N				Disconnect required
Liquidtight from disconnect to unit	Y				
Signs of Electrical damage	N				
Min. 12" & 30" clearances at all sides as req.	N				Bush along one side
Components					
Is lineset insulated	Y				
Filter / dryer installed	Y				
A-coil inspected	N				
Condensate drain line leads to				N	Hose running across floor, trip hazard
Trap installed on condensate line	N				
Secondary drain from A-coil installed?	N				
Roof drip protection for Condenser	N				
Window air conditioners	Y				At least 2 in closets, one installed in sunroom wall
