Property
Condition Report
For Bar / Restaurant

123 N. Chicago St.
Chicago, IL

Inspection Date: 1-1-11

PROPERTY CONDITION REPORT

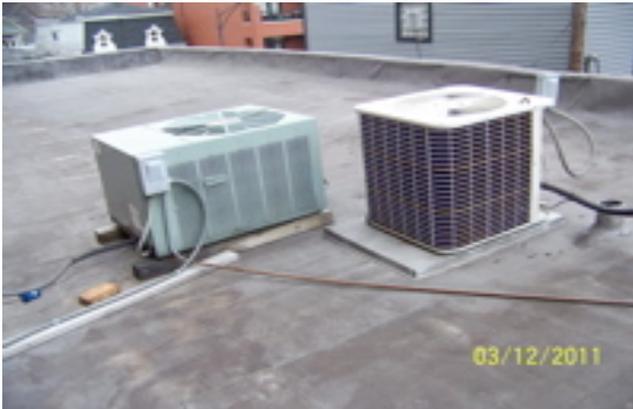
AC condensers on 2nd floor roof

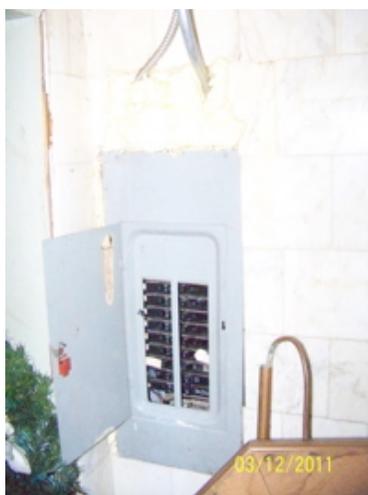
2nd floor panel, open slots
